The Honorable Earl F. Weener, Ph.D.
Member
National Transportation Safety Board

Examination of Reports on the *El Faro* Marine Casualty and
Coast Guard's Electronic Health Records System

Washington, DC • January 30, 2018

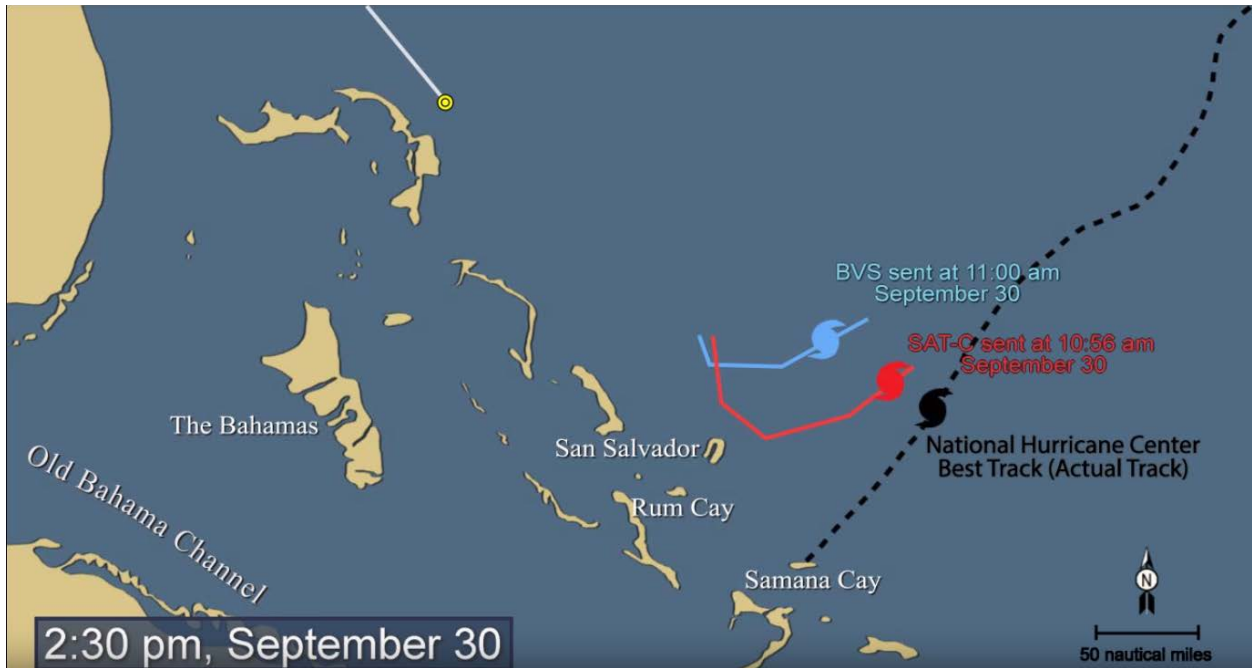
Figure 2 shows *El Faro*'s position at 2:30 p.m. on September 30, in relation to the storm's location and forecast tracks from SAT-C and BVS received that morning, as well as the NHC's poststorm best-track analysis of actual storm location. At 4:54 p.m., a SAT-C advisory received on the bridge indicated that the storm was moving further southwest. An updated BVS update was available for download at about 5:00 p.m., but it was consistent with the forecast that had been sent through SAT-C at 11:00 a.m.

Figure 2. Location of *El Faro* in relation to available weather forecasts and poststorm analysis at 2:30 p.m. on September 30.

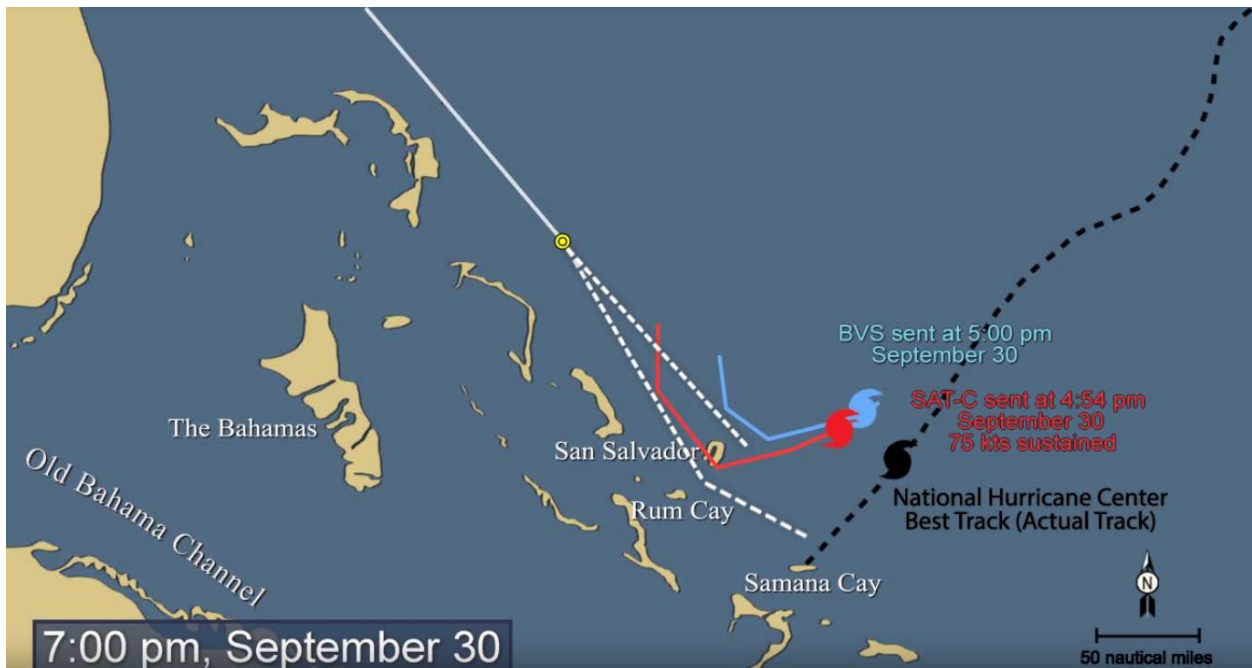
At around 7:00 p.m., the captain adjusted the course slightly south (**Figure 3**). At this point, the ship was about 180 nautical miles (nm) northwest of the center of Joaquin. The captain left the bridge at approximately 8:20 p.m. and was not detected on the bridge by the VDR until 4:09 a.m. on October 1.

Figure 3. *El Faro*'s location, depicting the course change to the south, in relation to its prior course, available weather forecasts, and poststorm analysis at 7:00 p.m. on September 30.

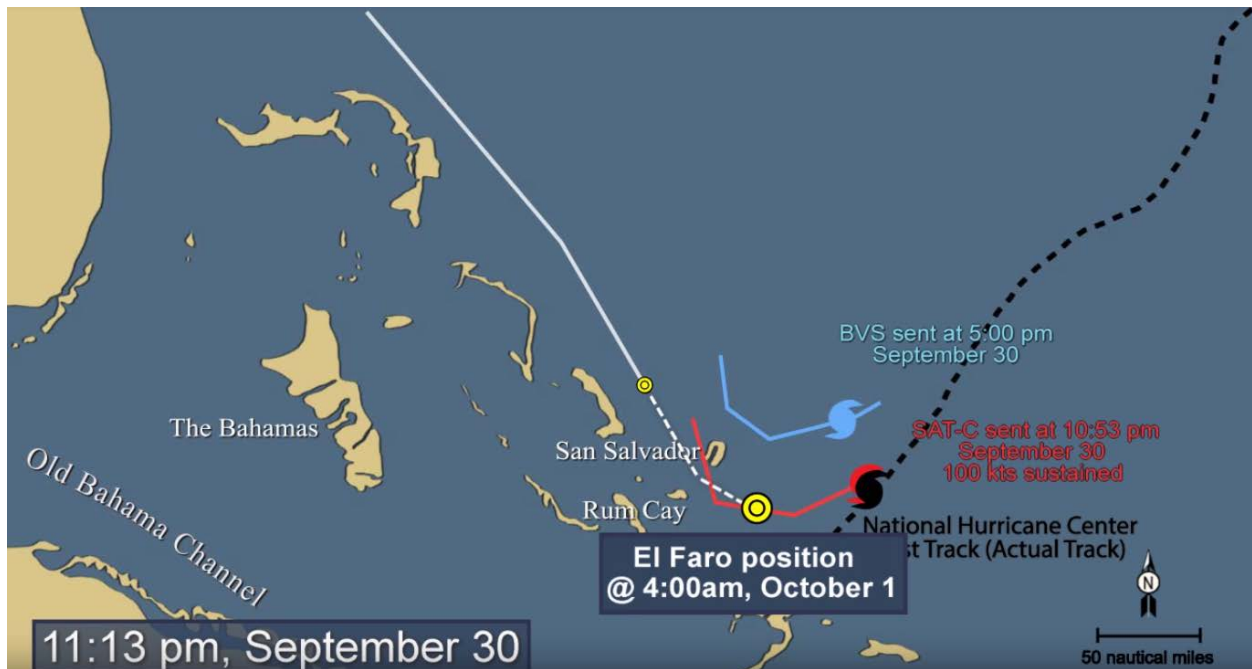
At 10:53 p.m., a SAT-C advisory received on the bridge indicated that the storm was centered about 120 nm southeast of *El Faro*'s position and was moving southwest at 5 knots. Maximum sustained winds were 100 knots, with gusts to 120 knots. At 11:05 p.m., the third mate called the captain from the bridge telephone to notify him of the SAT-C advisory. At 11:13 p.m., the third mate called the captain again and suggested diverting to the south, noting that at 4:00 a.m. on October 1, they would be 22 miles from the center of the storm (**Figure 4**). This information did not cause the captain to authorize a course change. Later, the third mate told the able seaman on watch that the captain thought they would be south of the storm.

Figure 4. *El Faro*'s location, depicting the current course and expected position, available weather forecasts, and poststorm analysis at 11:13 p.m. on September 30.

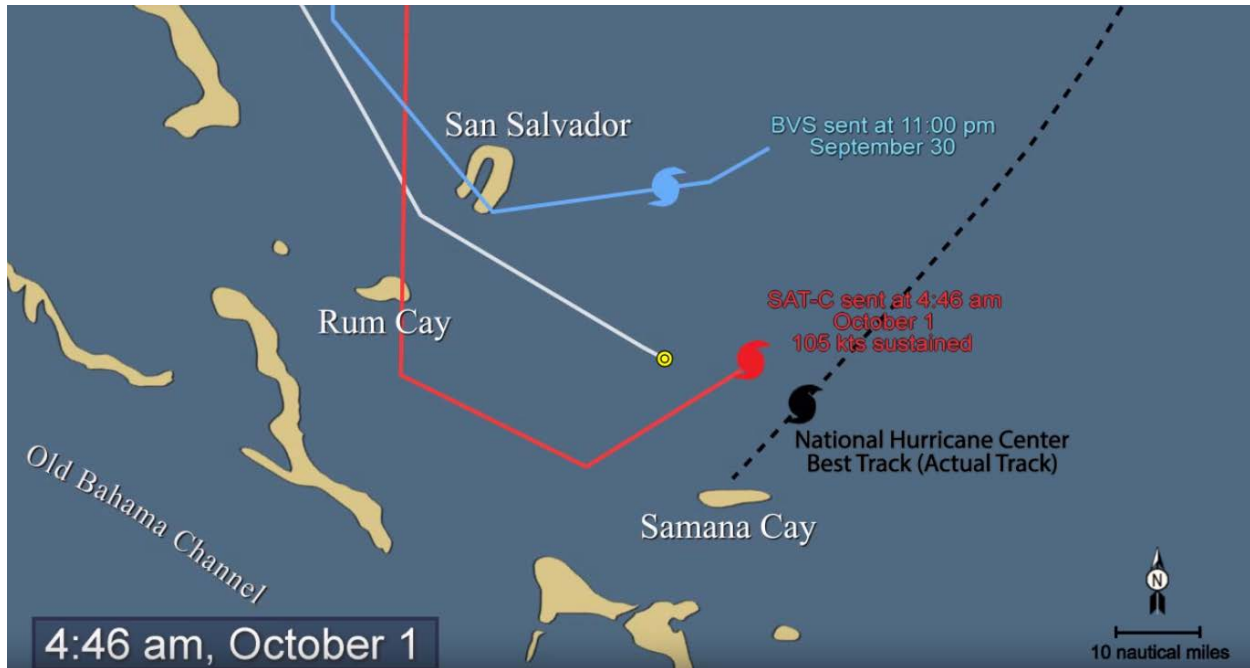
At 4:09 a.m., the captain arrived back on the bridge, and at 4:45 a.m., he downloaded a BVS weather file that had been sent at 11:04 p.m. the night before. Joaquin's position, forecast track, and intensity given in the file were consistent with the data in the advisory that had been delivered to the bridge via SAT-C almost 12 hours before, at 4:54 p.m. the previous afternoon. At 4:46 a.m., *El Faro*'s SAT-C terminal received an advisory indicating that *El Faro* was 11 nm northwest of the storm center (**Figure 5**).

Figure 5. *El Faro*'s location in relation to available weather forecasts and poststorm analysis at 4:46 a.m. on October 1.
