KINGSTON RCA

Kingston Dredge Cell Failure

Root Cause Failure Analysis

AECOM
Bill Walton, P.E., S.E., F.ASCE

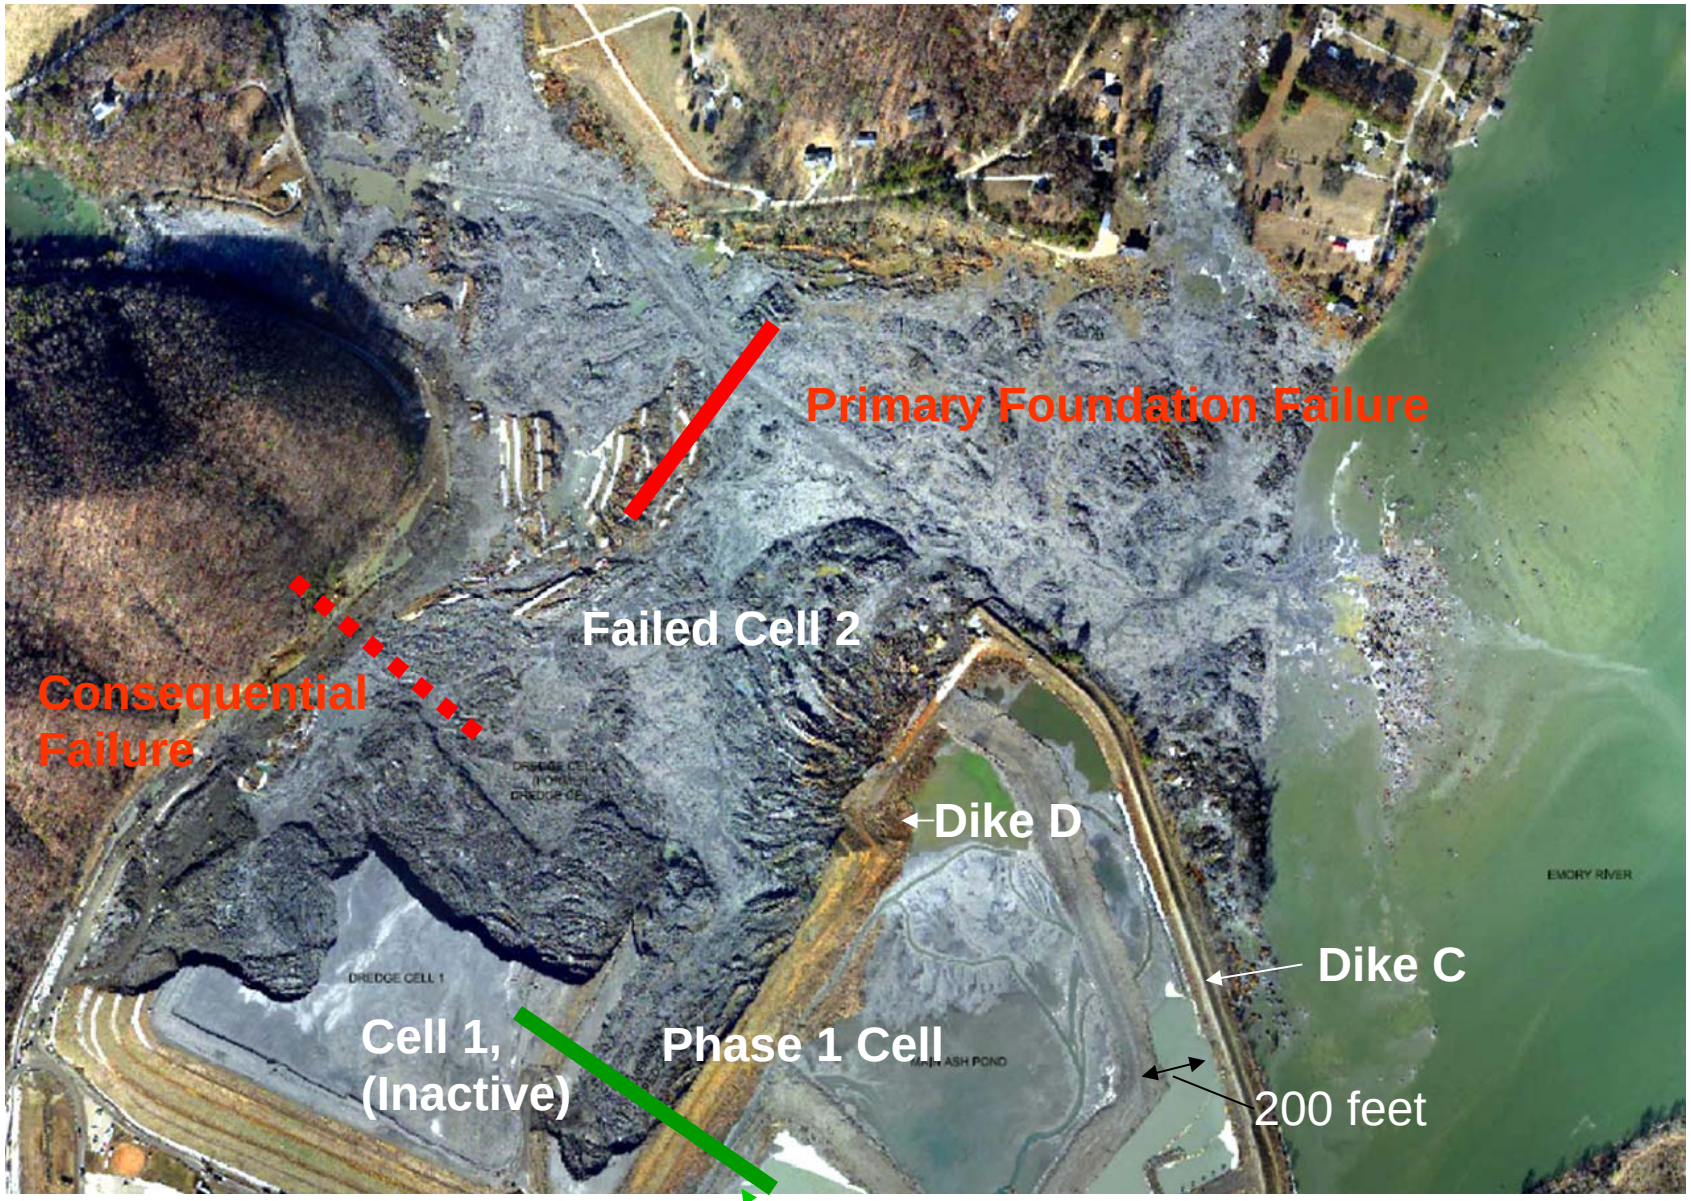
Pre-failure Condition 4-5-2008

Post Failure Condition 12-30-08

No Foundation Failure

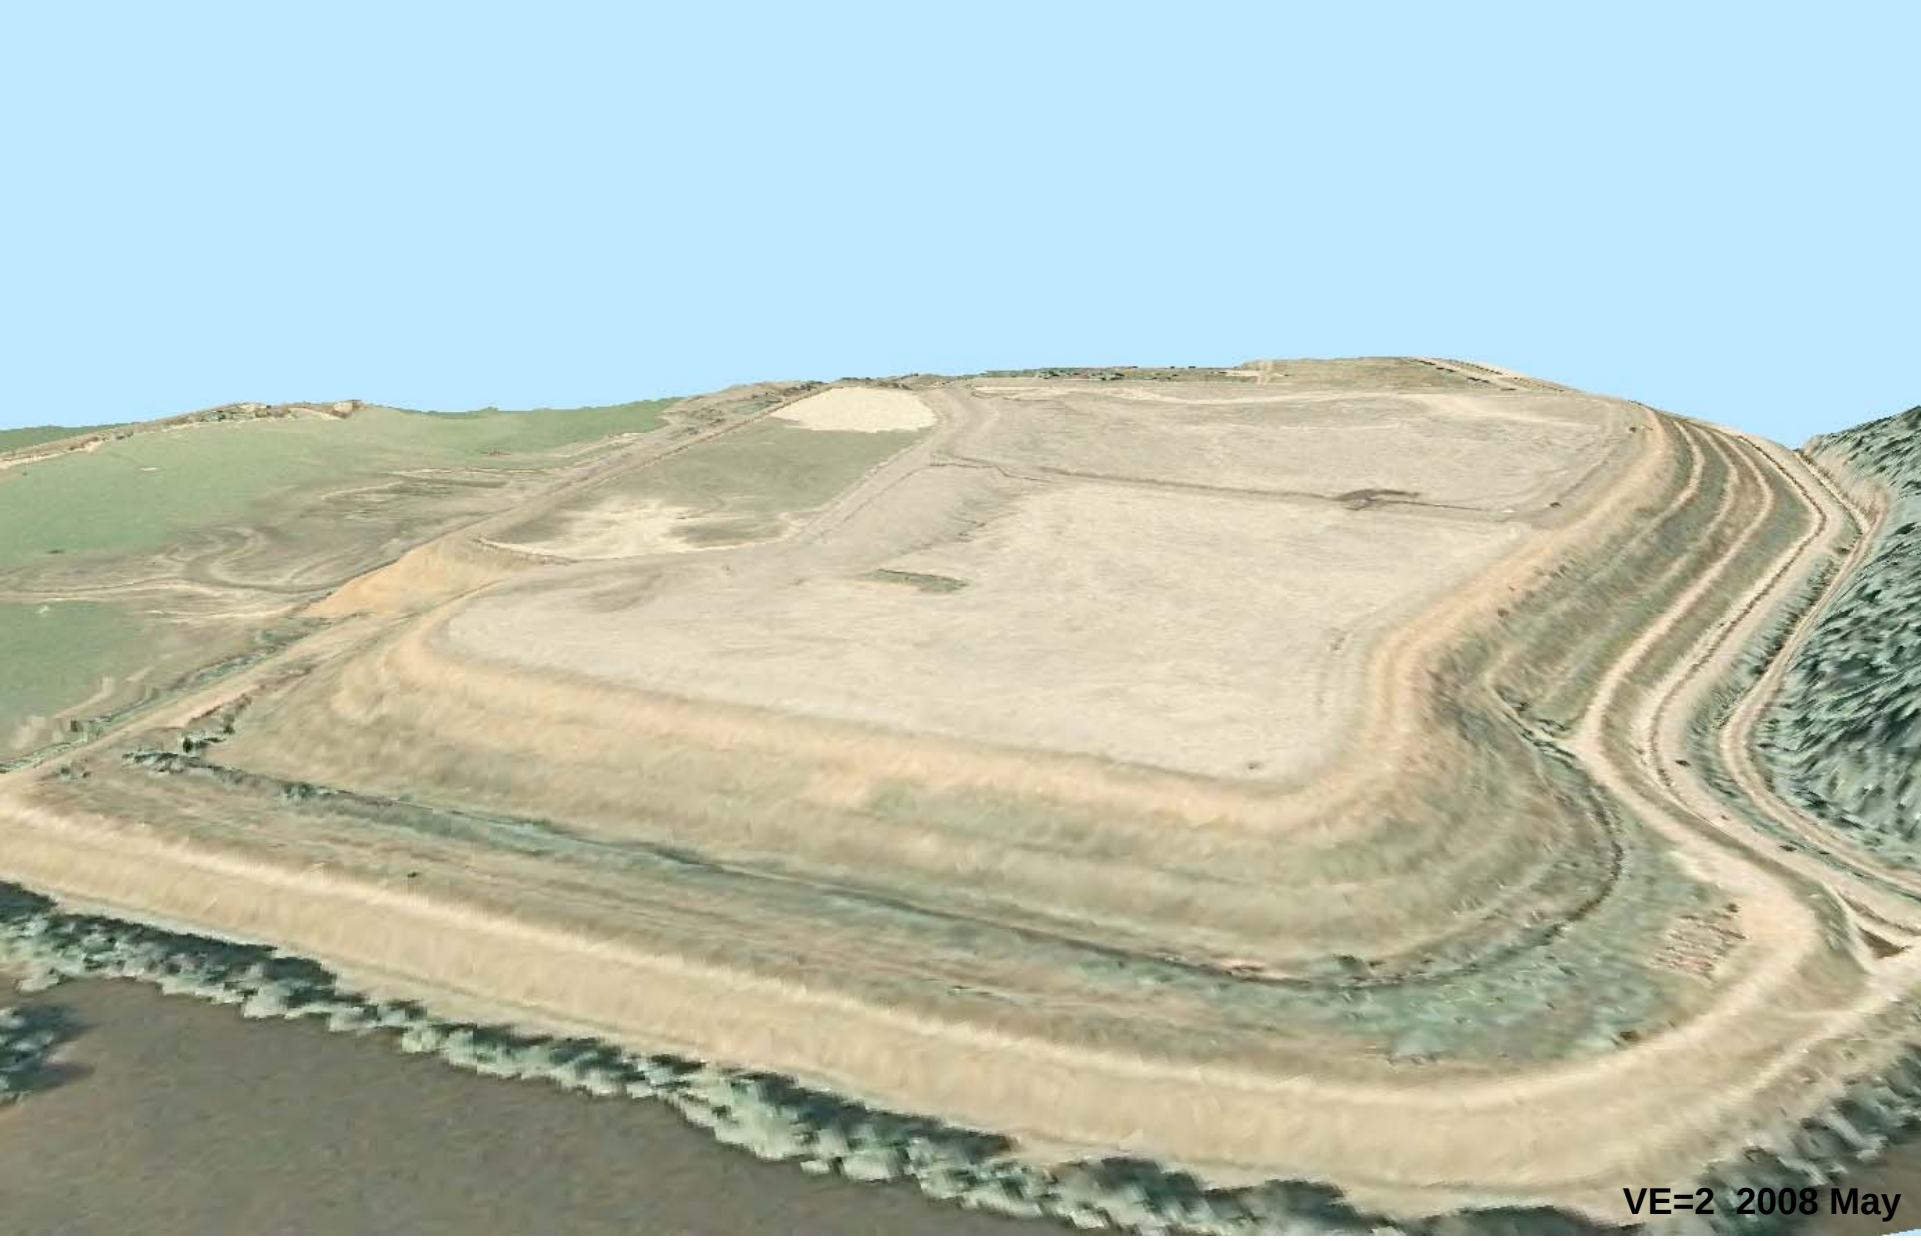
May 2008 Air Photo and Topography from Pre-Failure from TVA Surveys

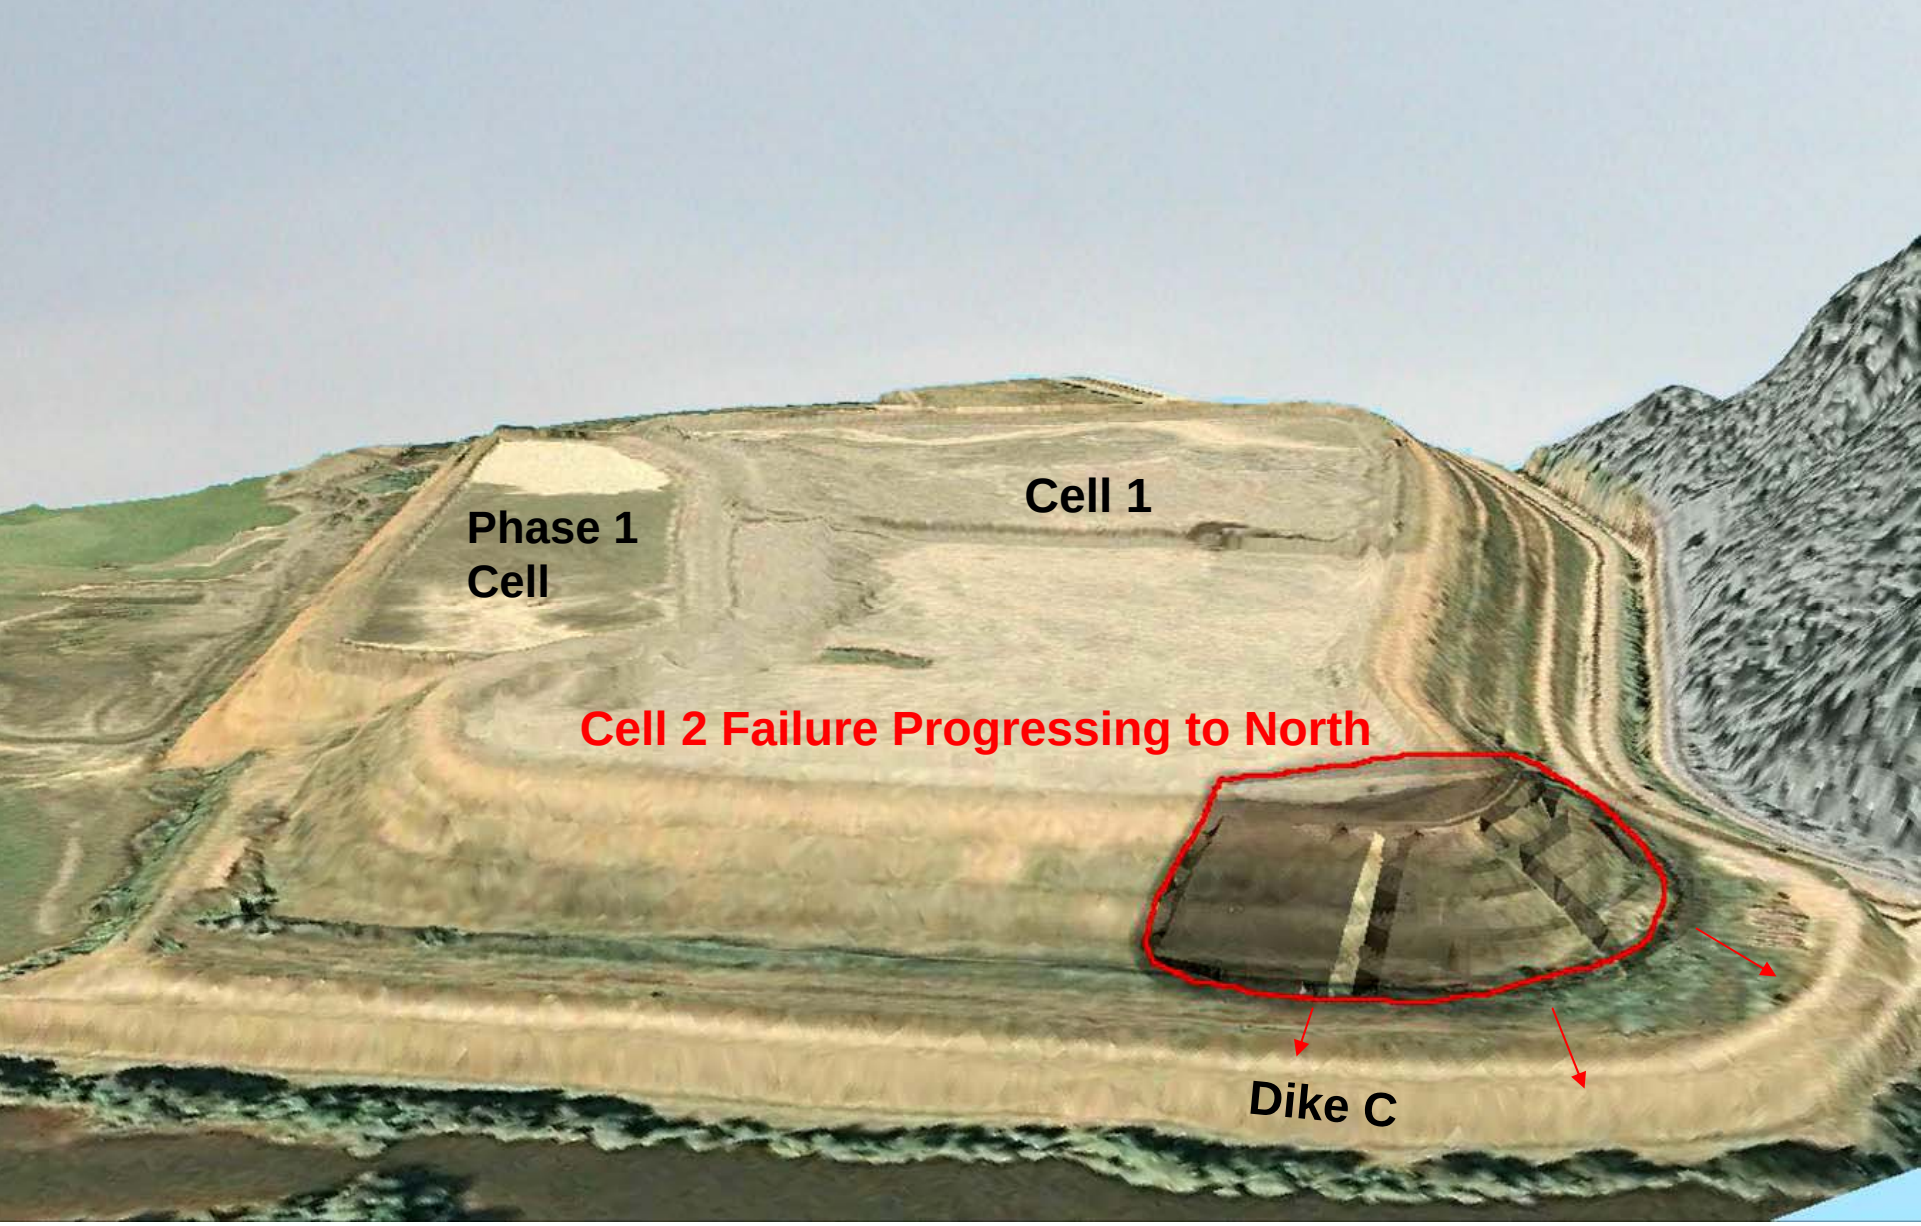
December 22, 2008 Expected Failure Location at NW Corner of Cell 2

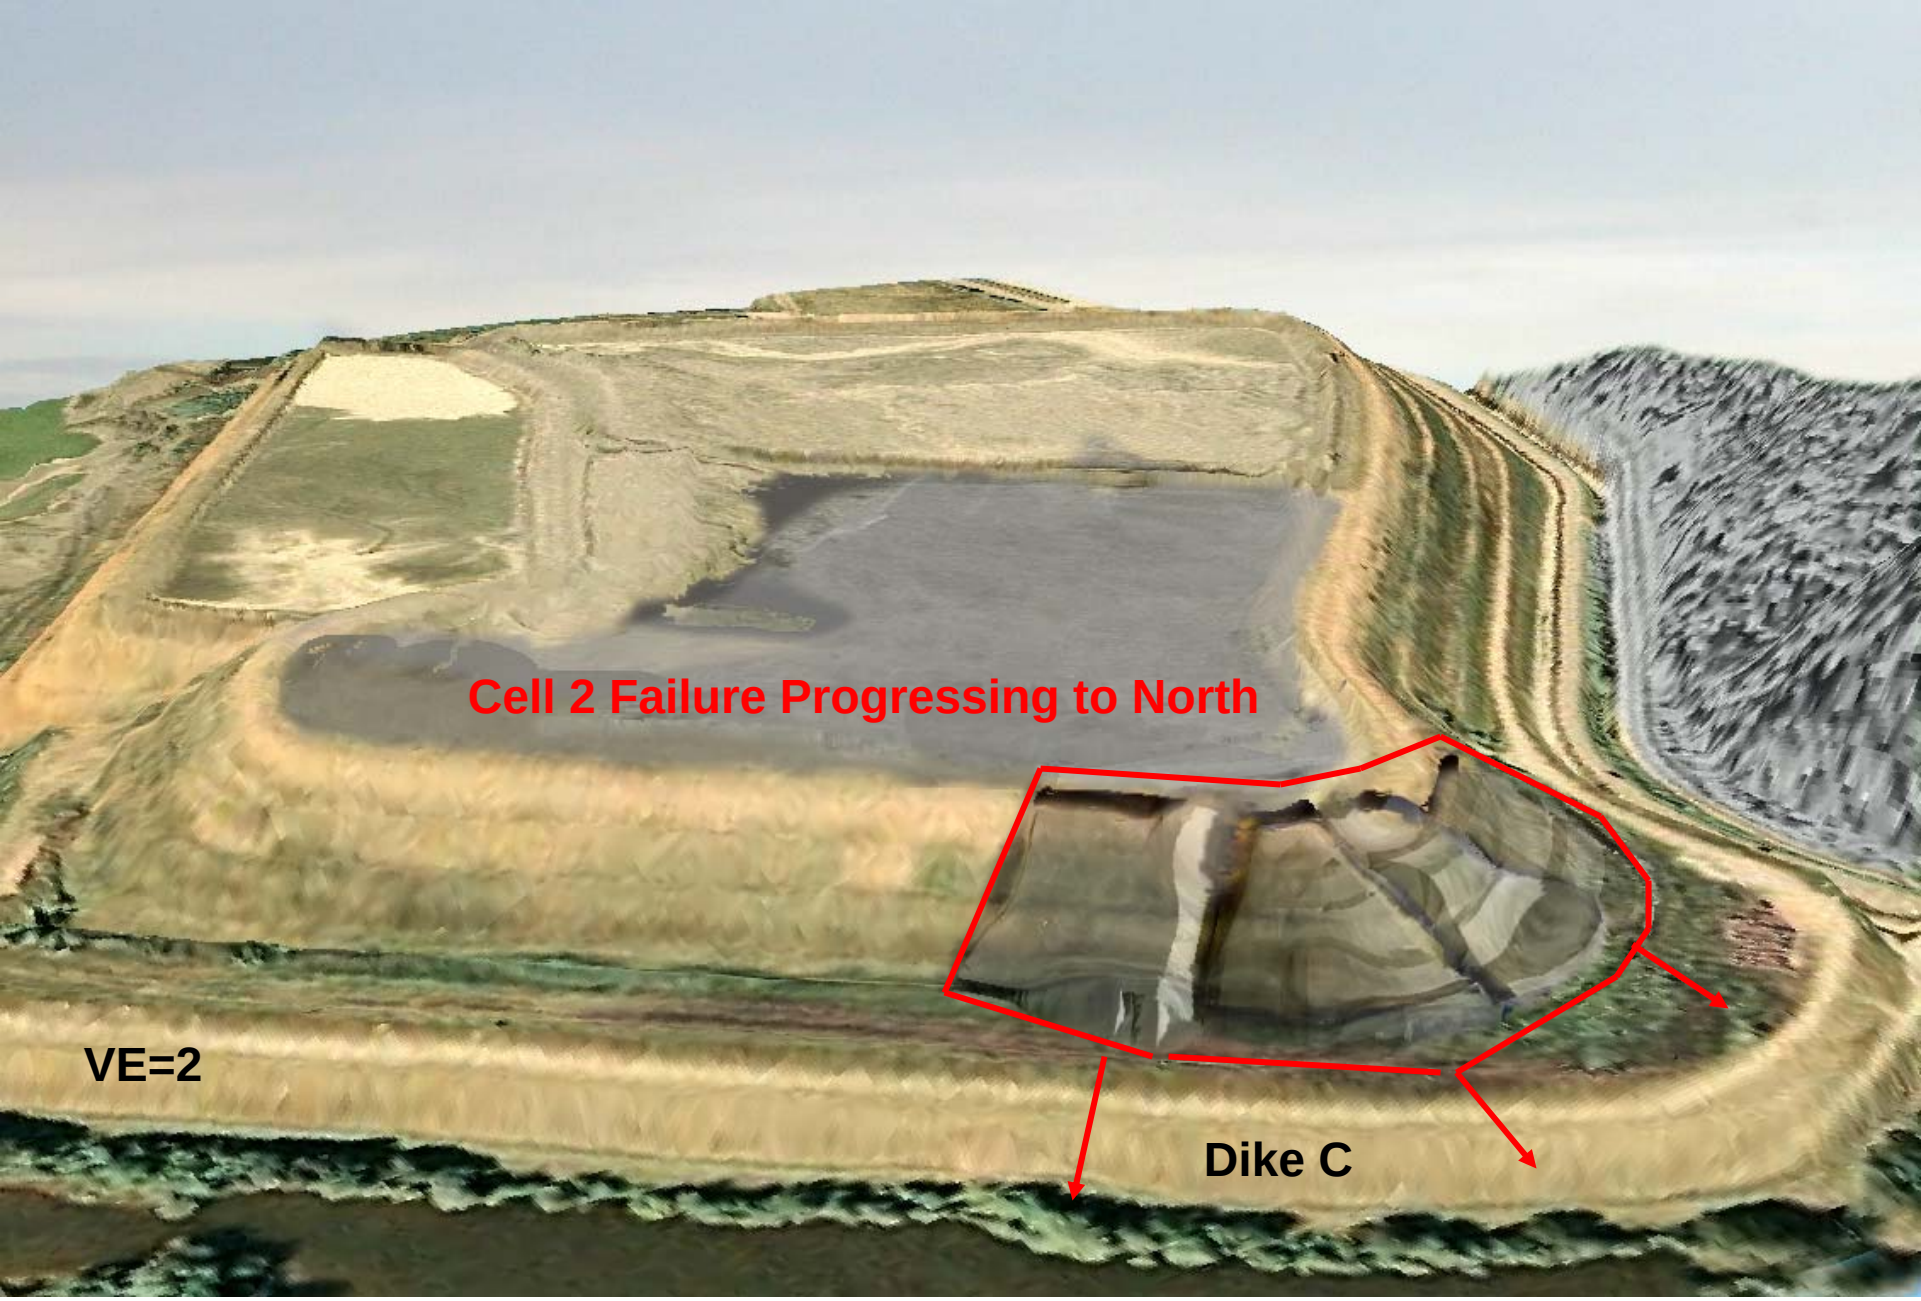
December 22, 2008 Expected Failure Location at NW Corner of Cell 2

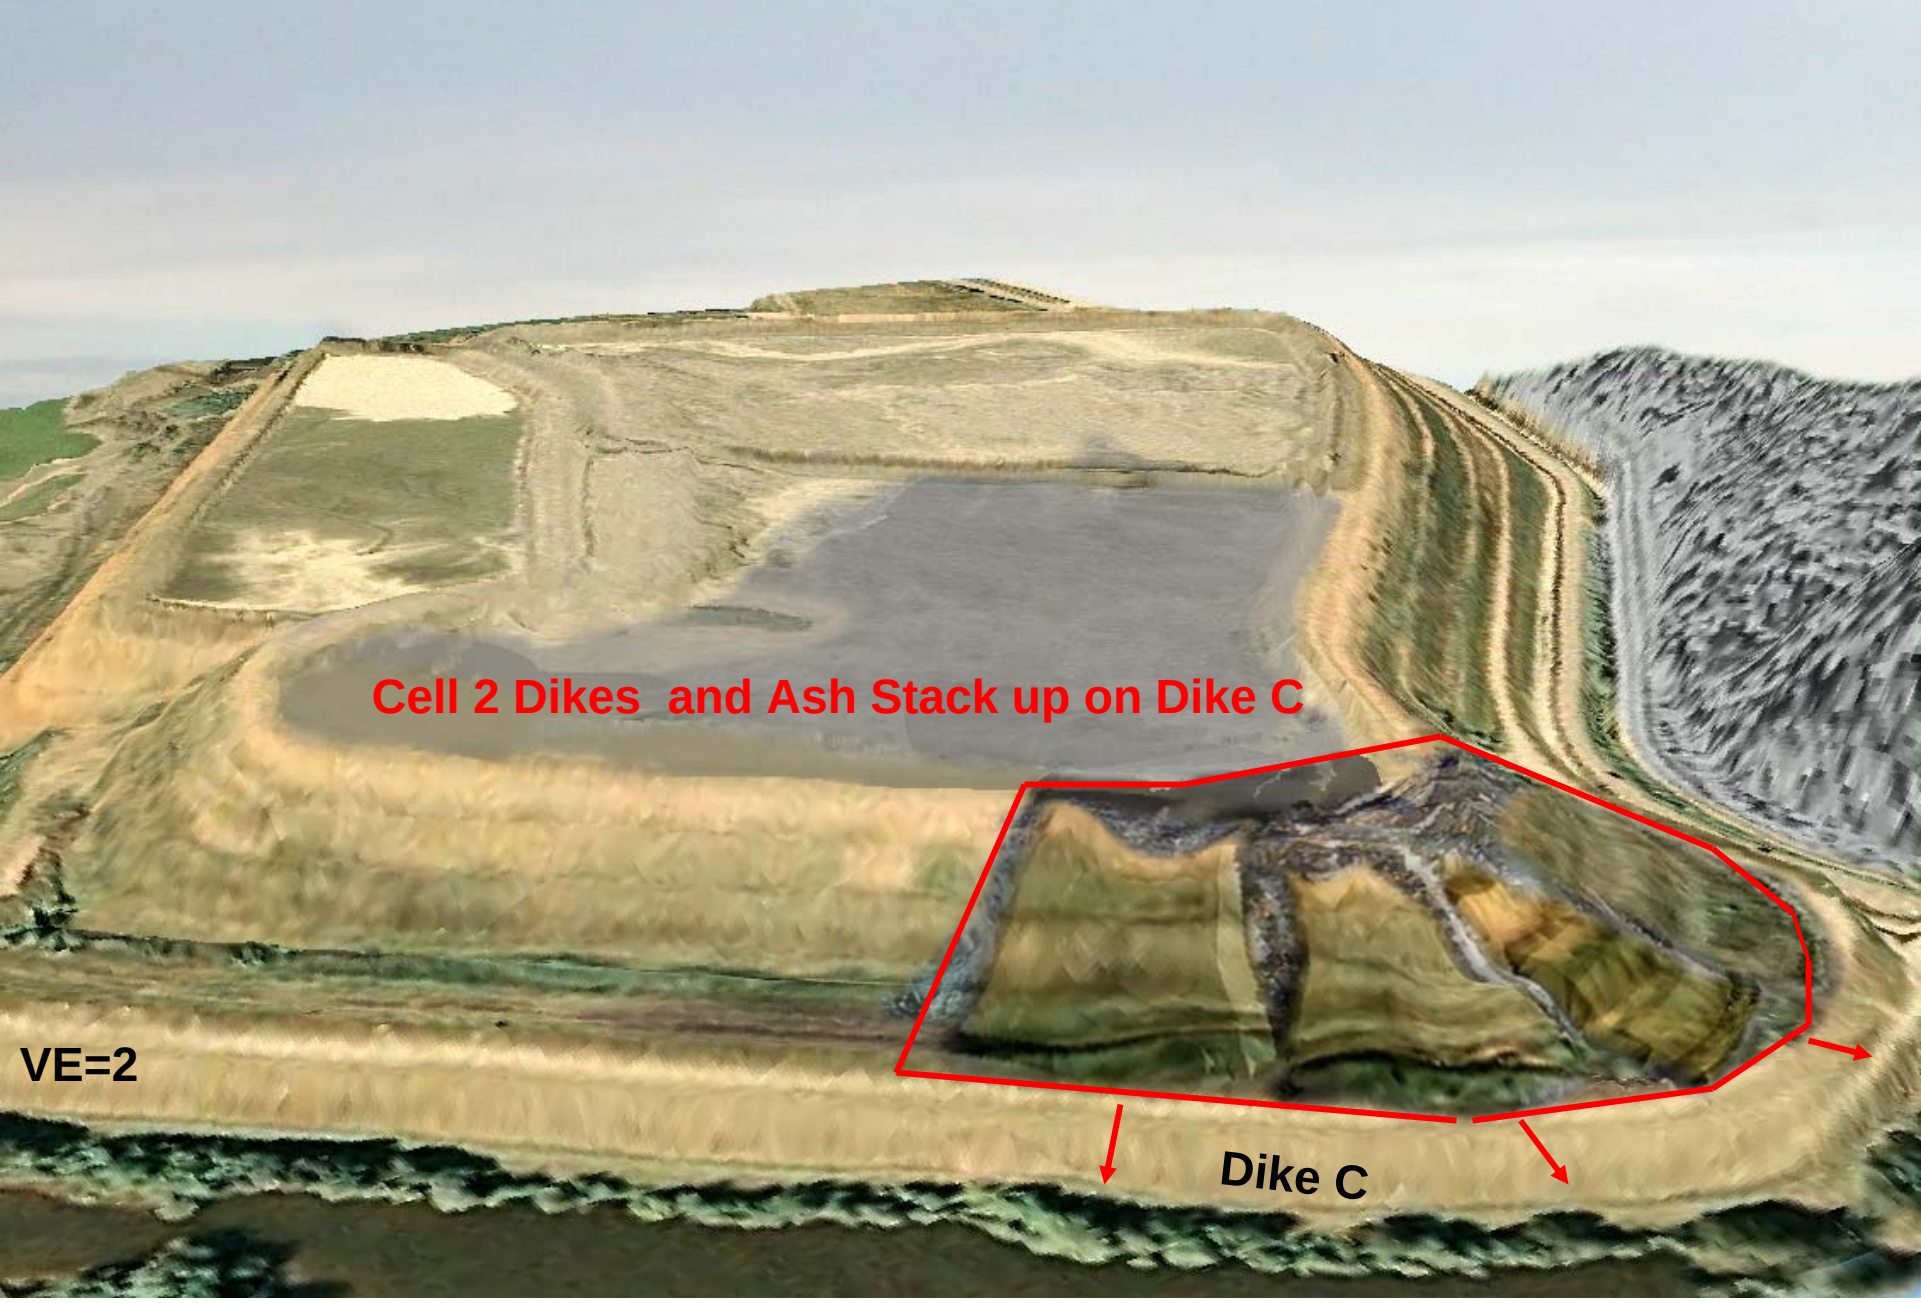
December 22, 2008 Expected Failure Mode at NW Corner of Cell 2

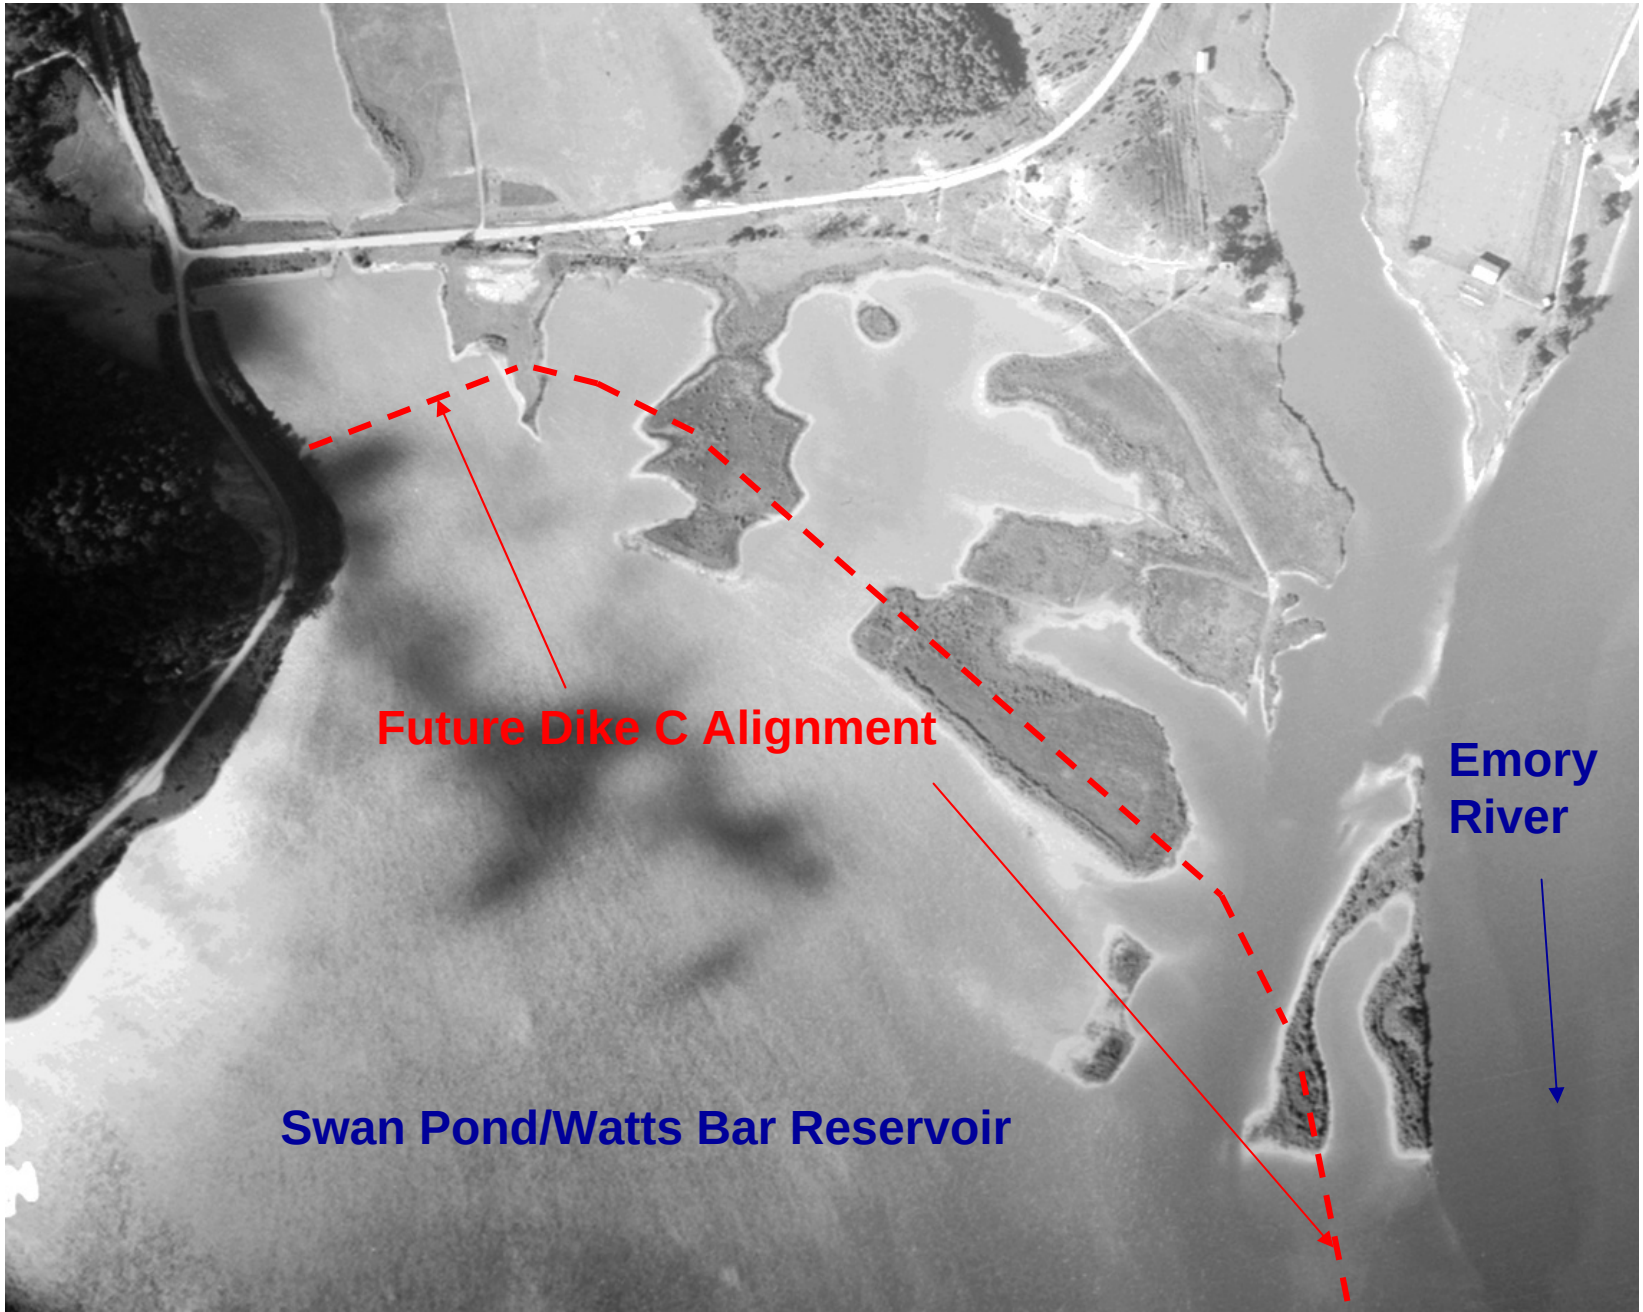
09-23-1949

Future Dike C Alignment
Emory River
Swan Pond/Watts Bar Reservoir

Plant Discharged Ash to Reservoir

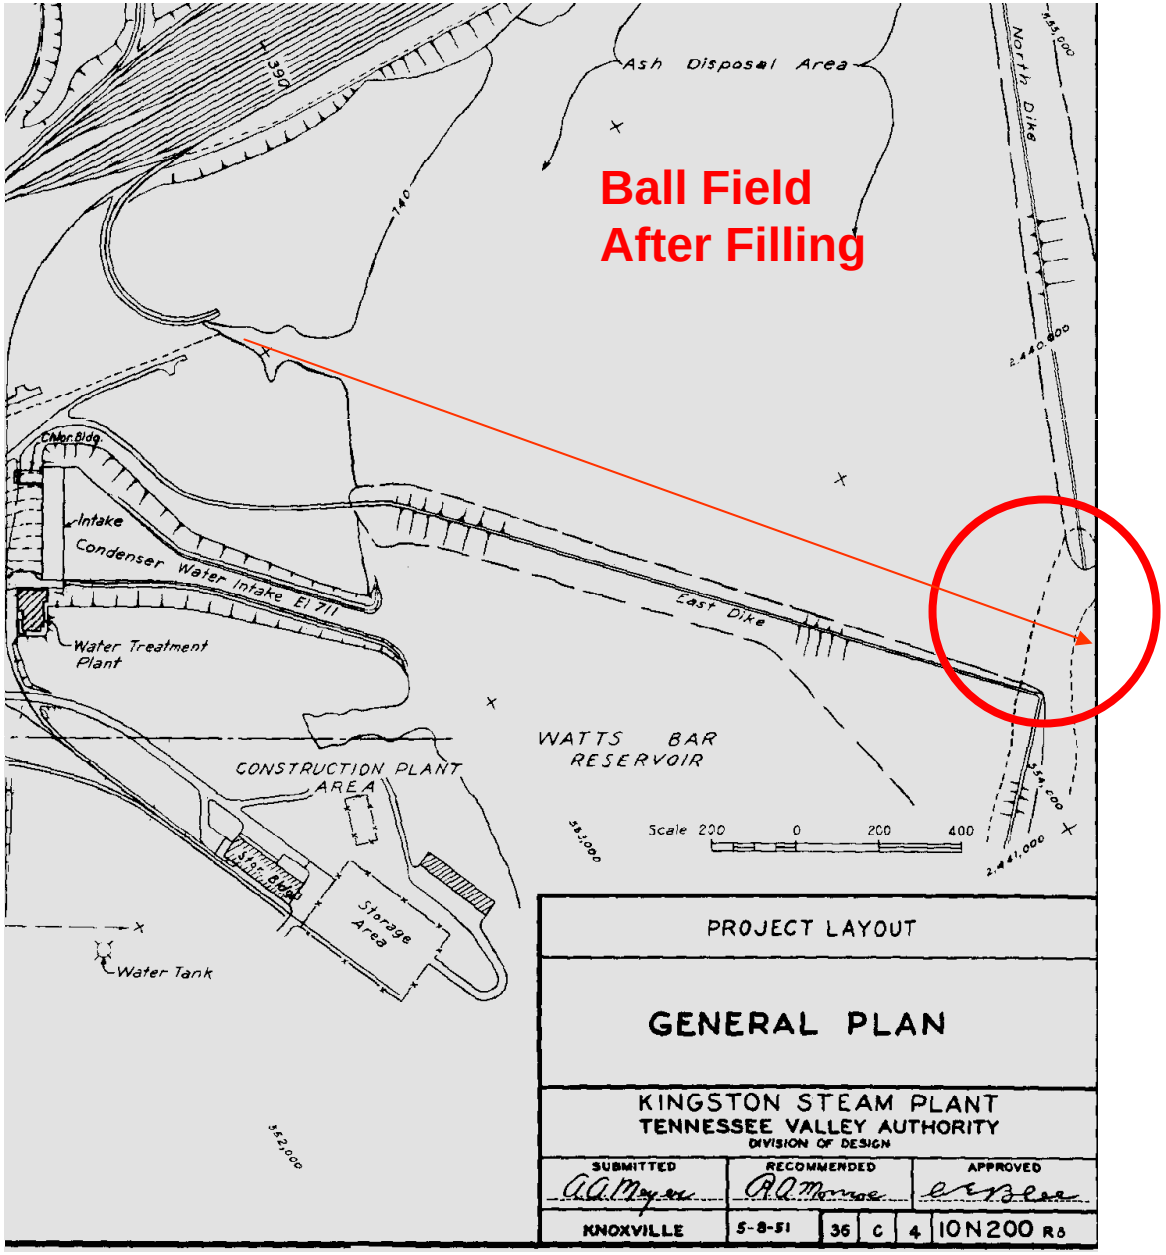
Prior to Dike C
No Closure
Open to Reservoir
1954 to 1958

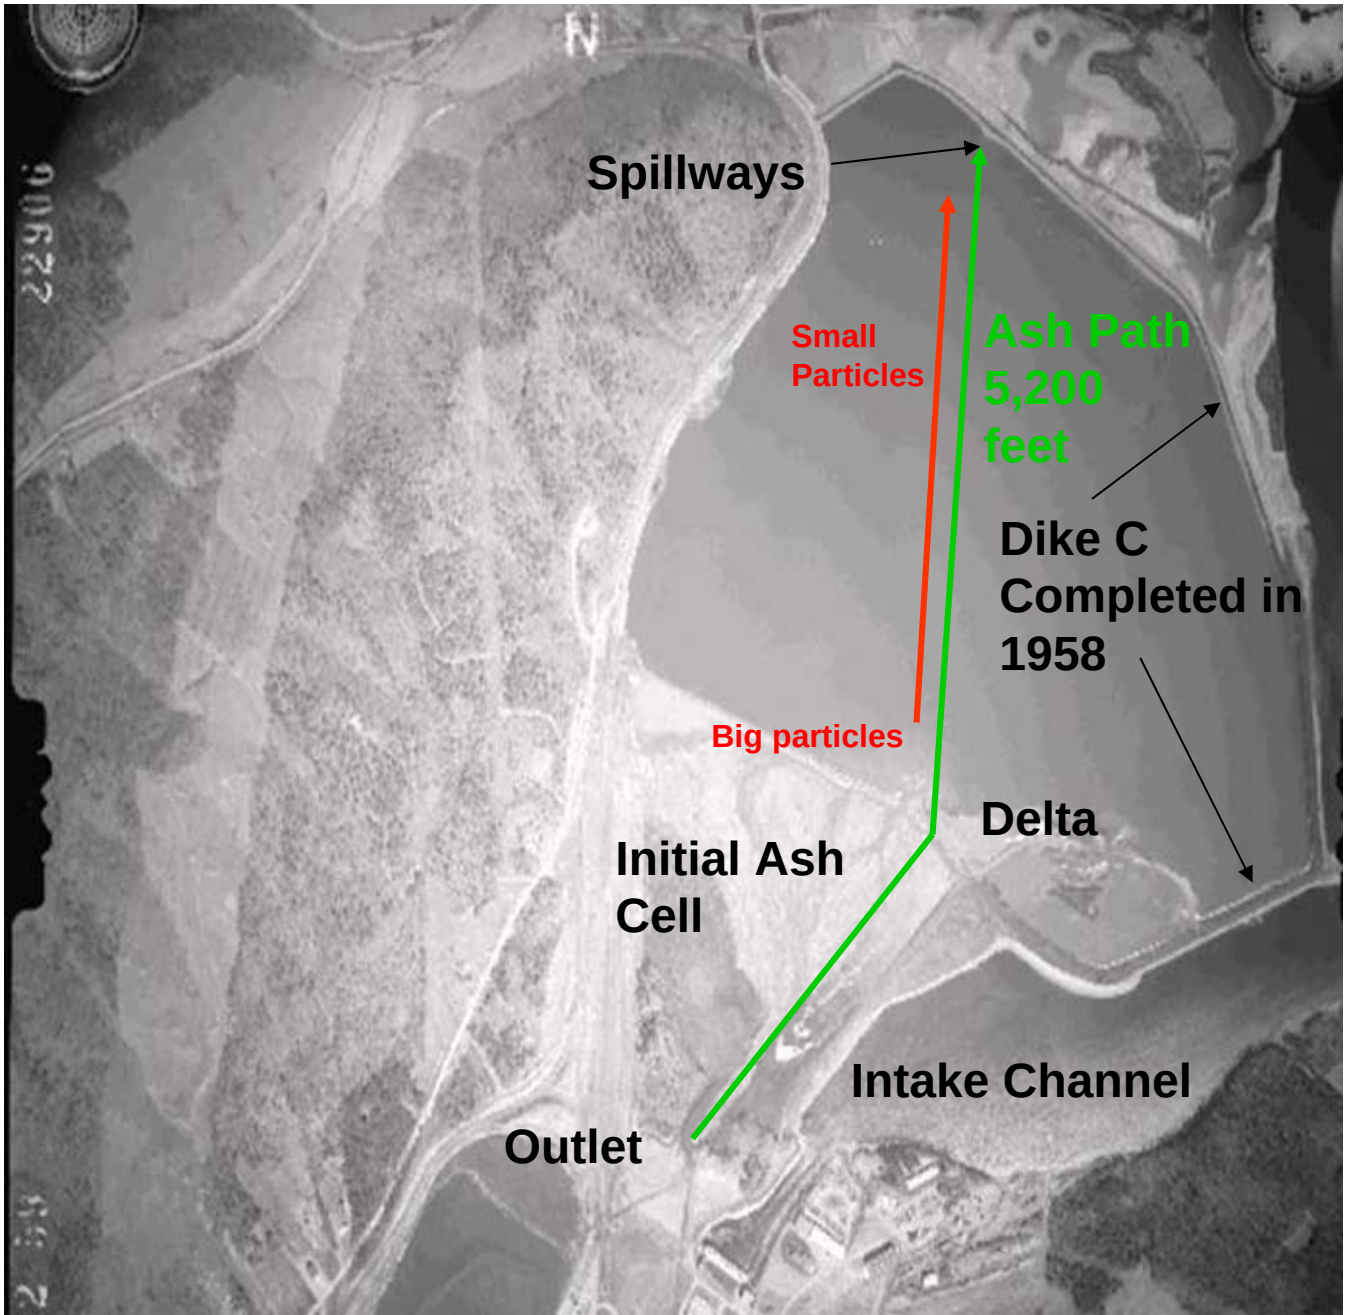
3-22-1959

N
Spillways
Small Particles
Ash Path 5,200 feet
Dike C Completed in 1958
Big particles
Delta
Initial Ash Cell
Intake Channel
Outlet

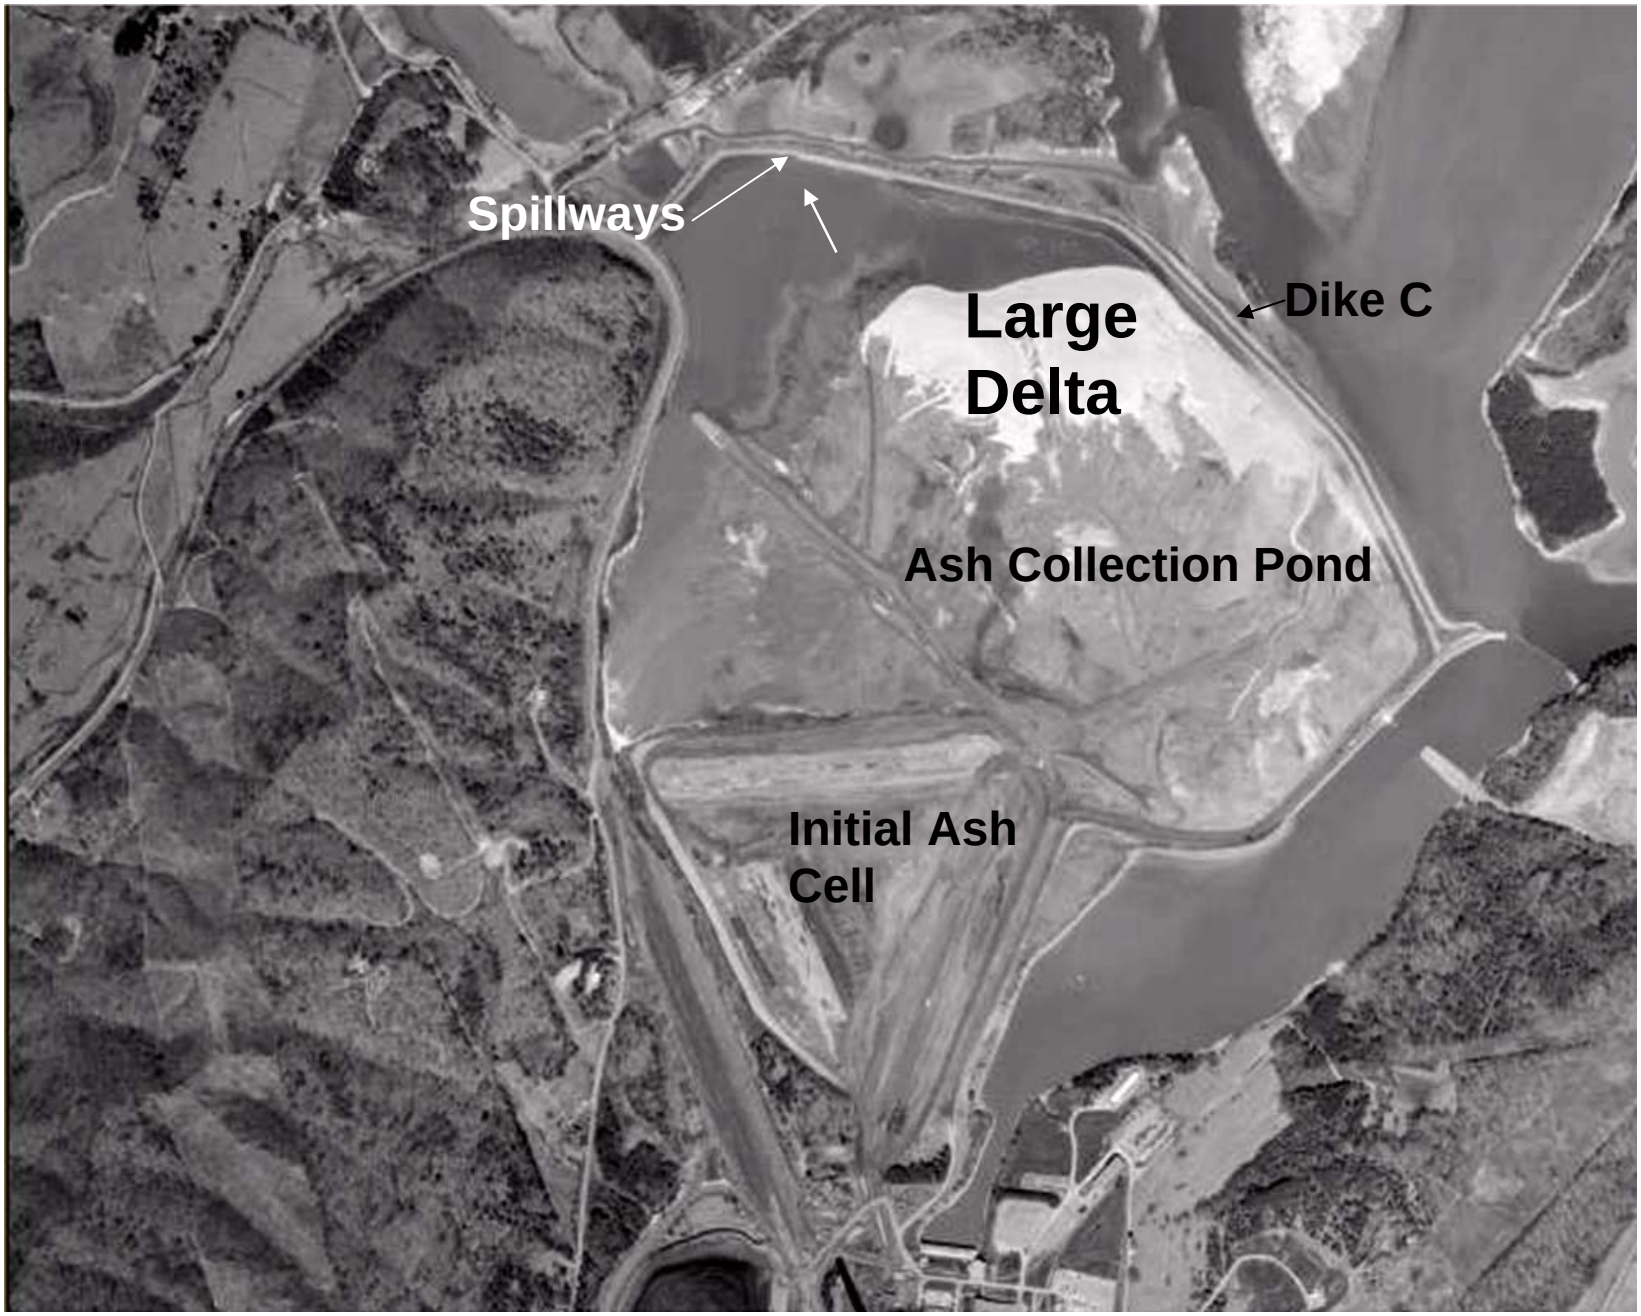
1976

Spillways
Large Delta
Dike C
Ash Collection Pond
Initial Ash Cell

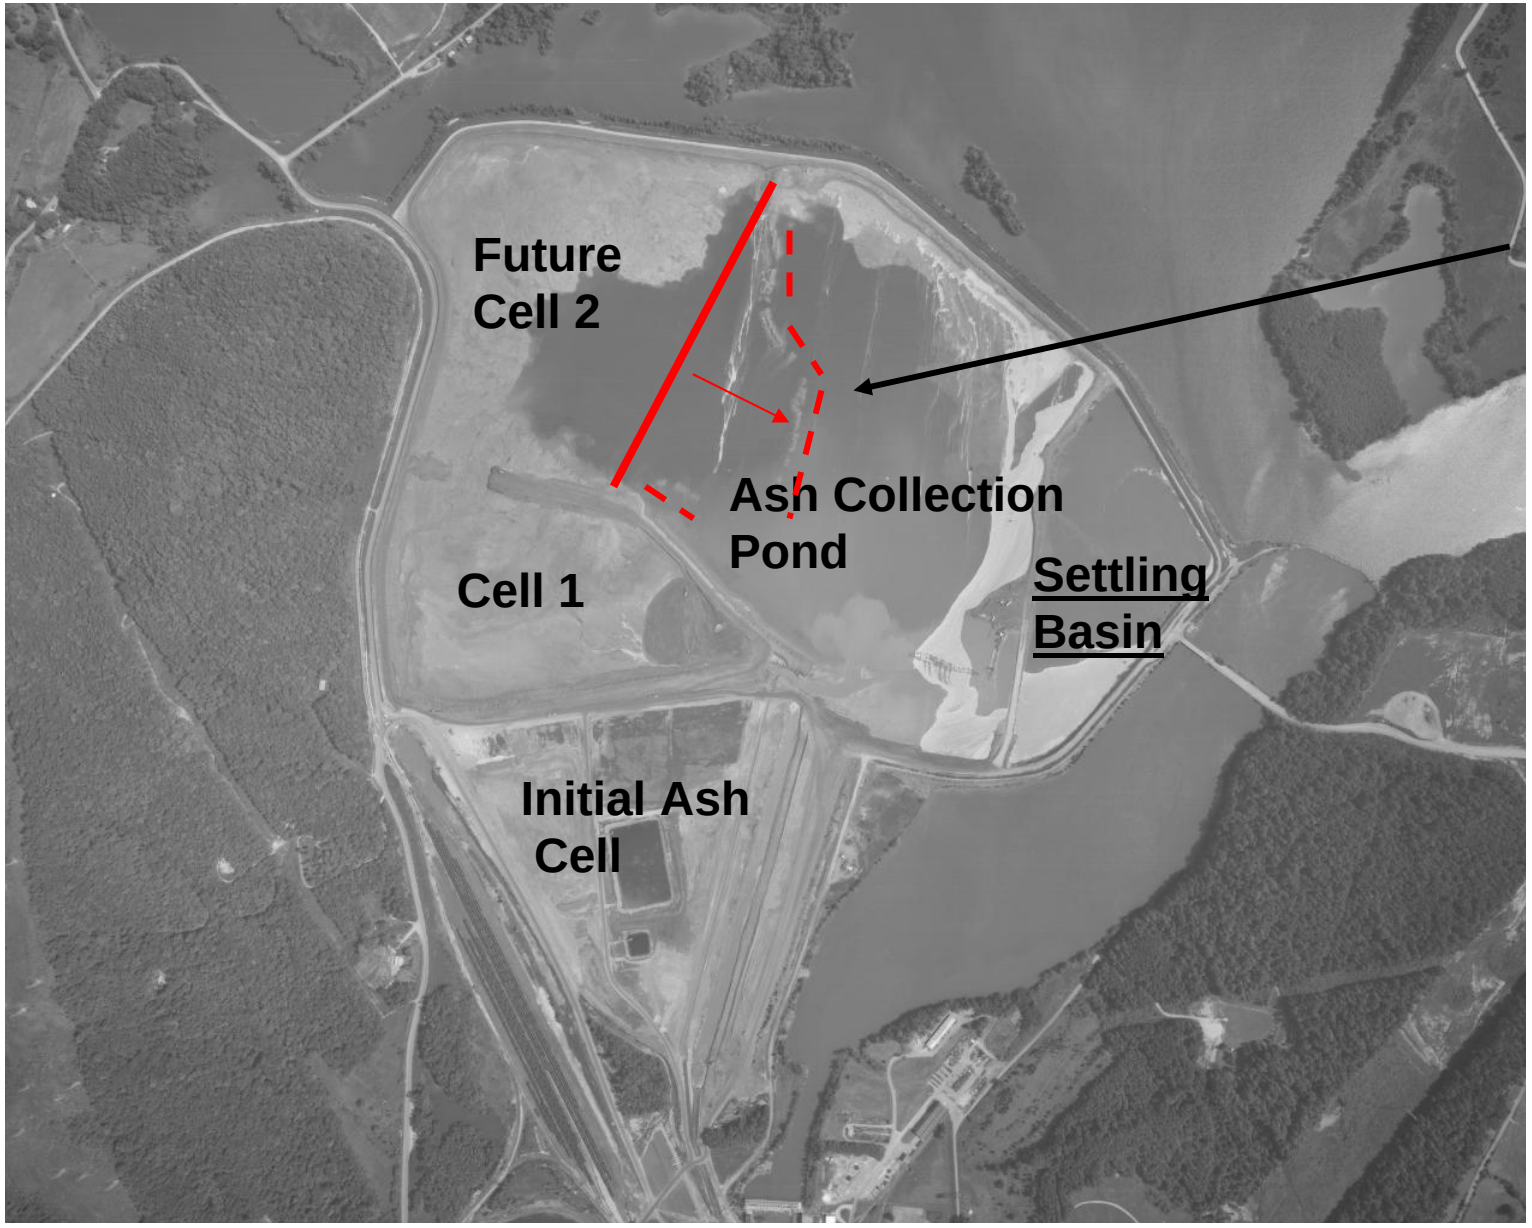
8-24-84

August 8, 1984 Divider Dike D Failure
