KINGSTON RCA

Kingston Dredge Cell Failure

Root Cause Failure Analysis

AECOM
Bill Walton, P.E., S.E., F.ASCE

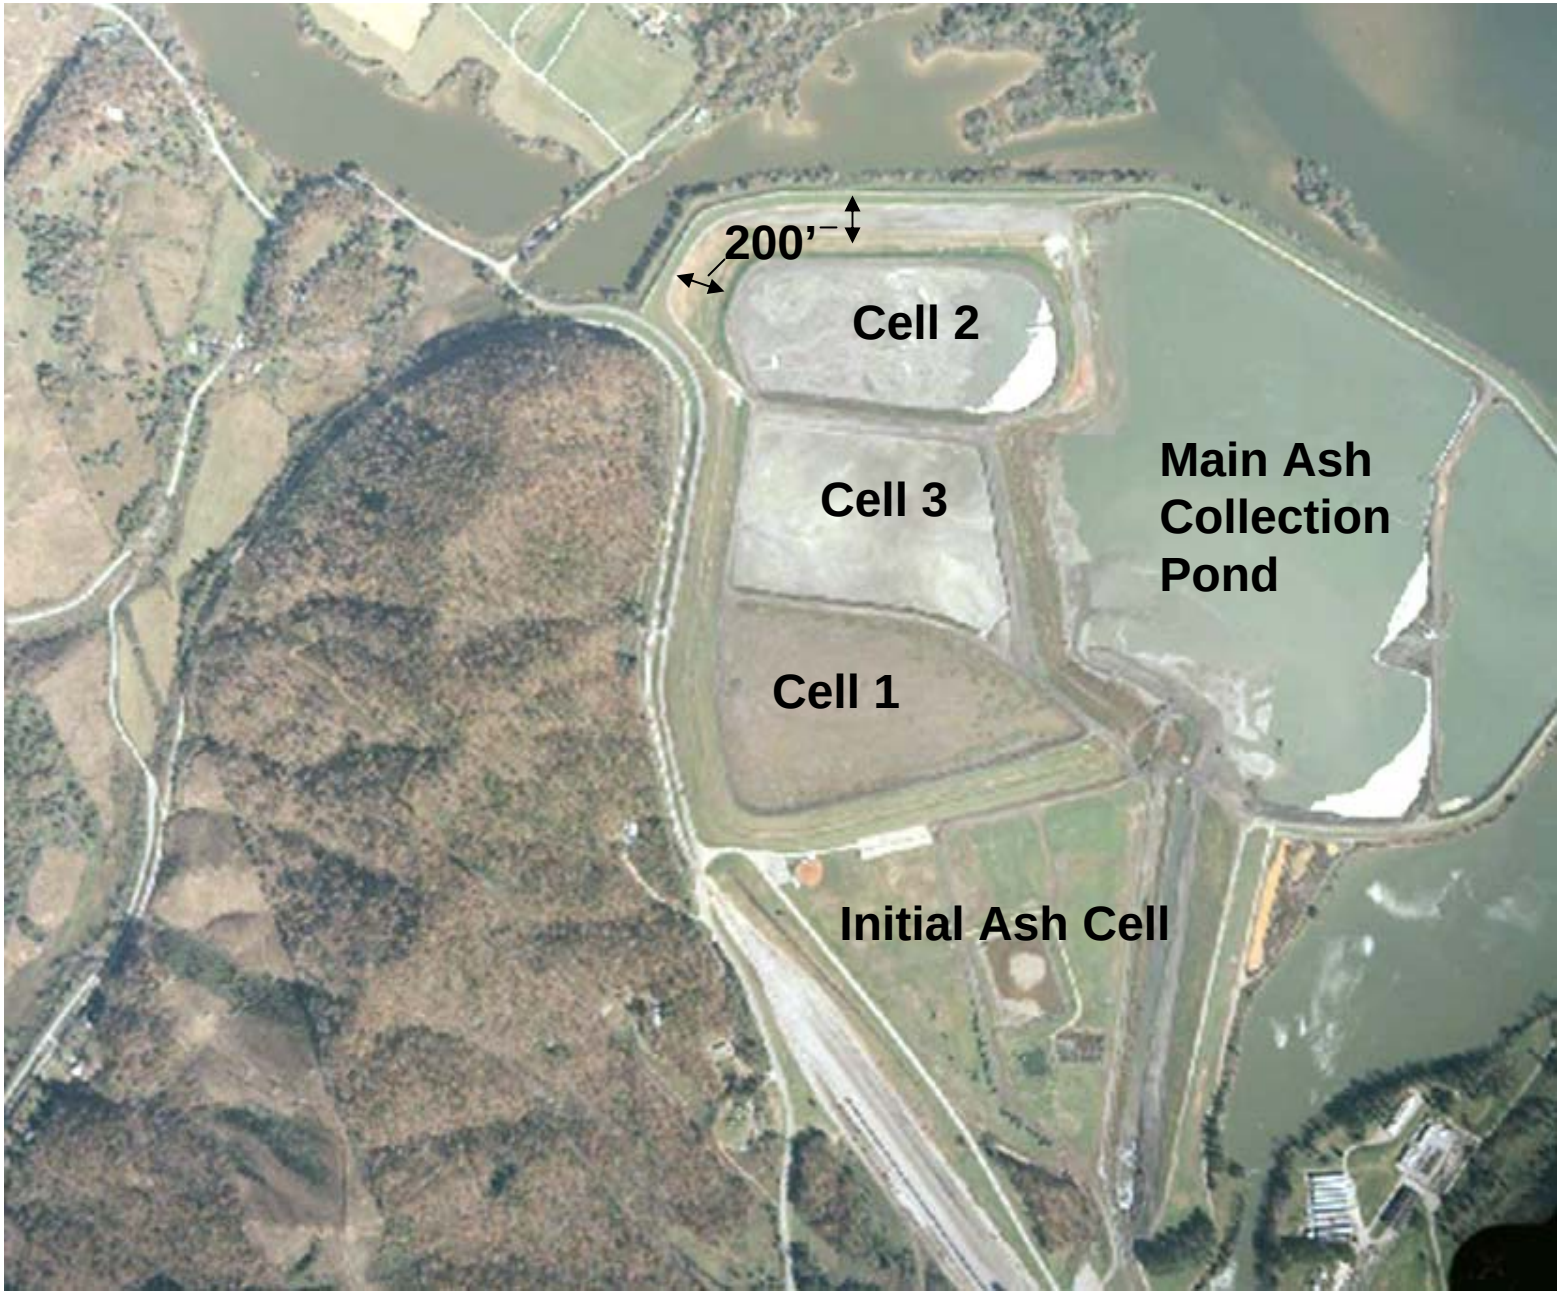
11-3-1996

200'
Cell 2
Cell 3
Main Ash
Collection
Pond
Cell 1
Initial Ash Cell

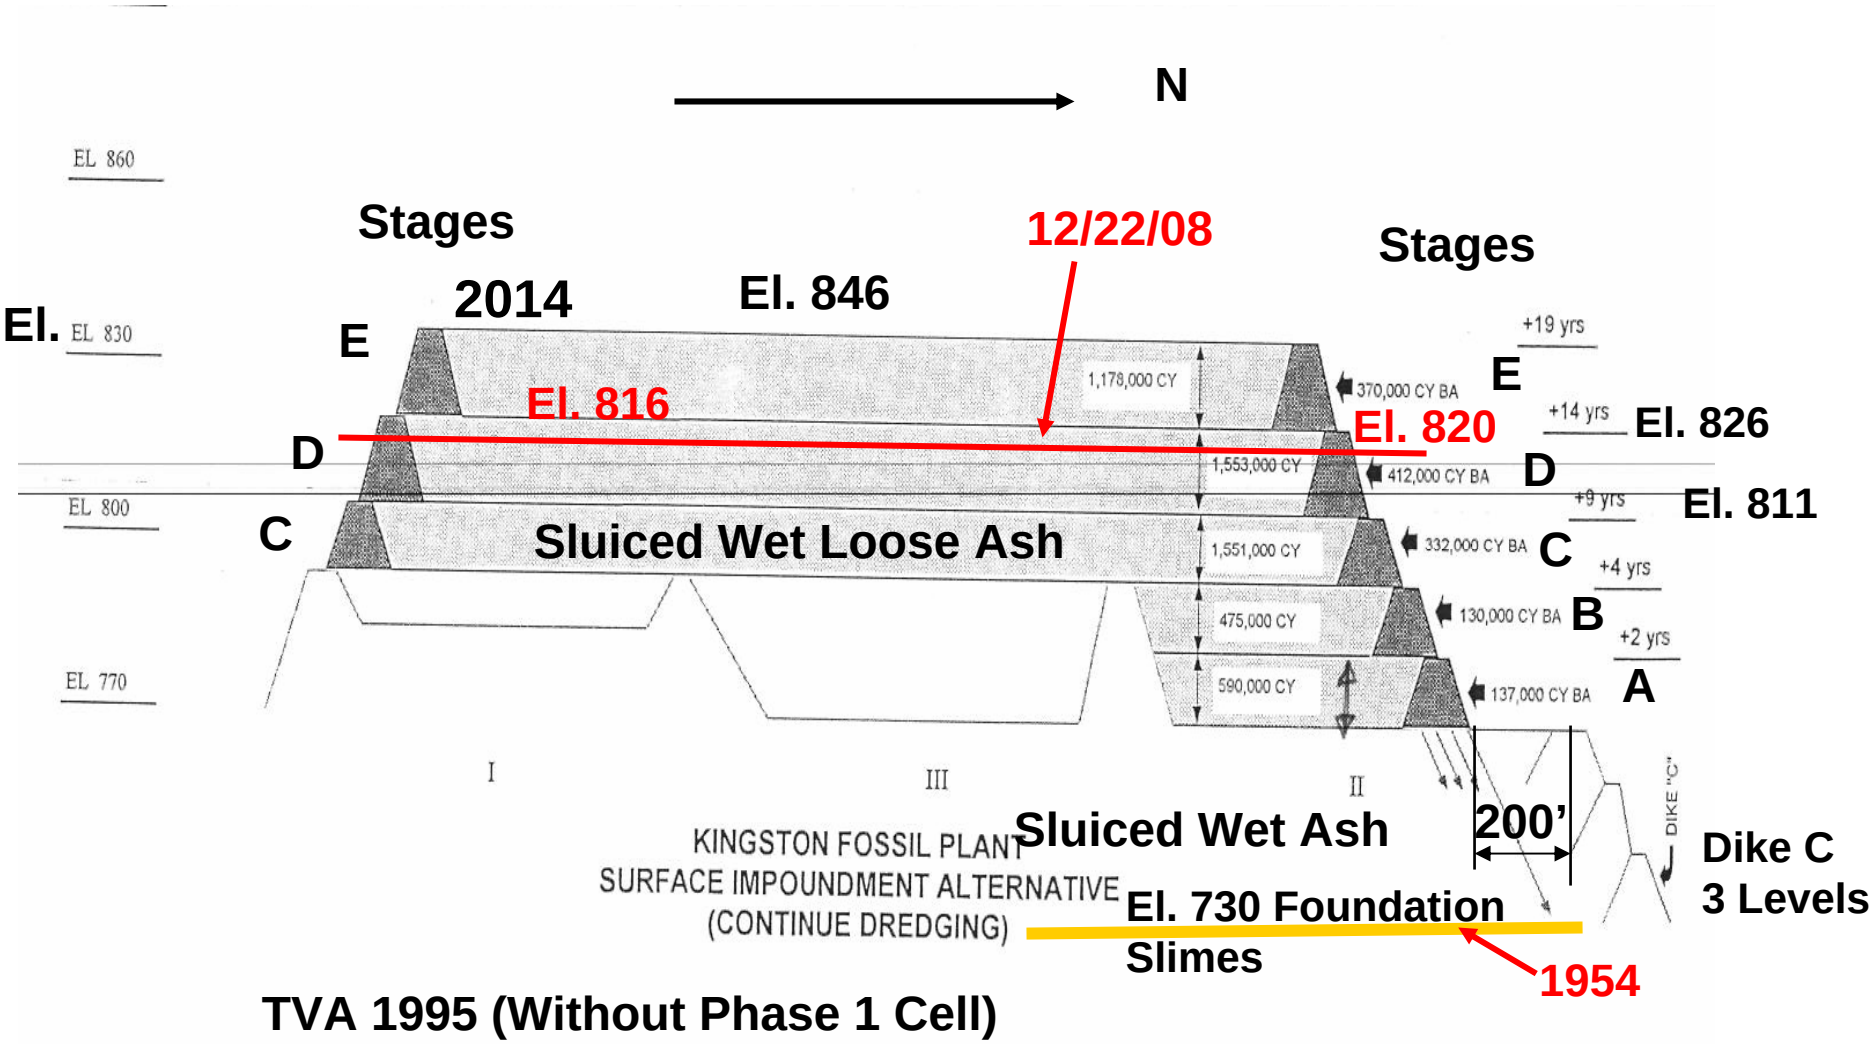
Active Cell 2 Filling, Dike Containment, and Foundation Supporting Loose Wet Ash

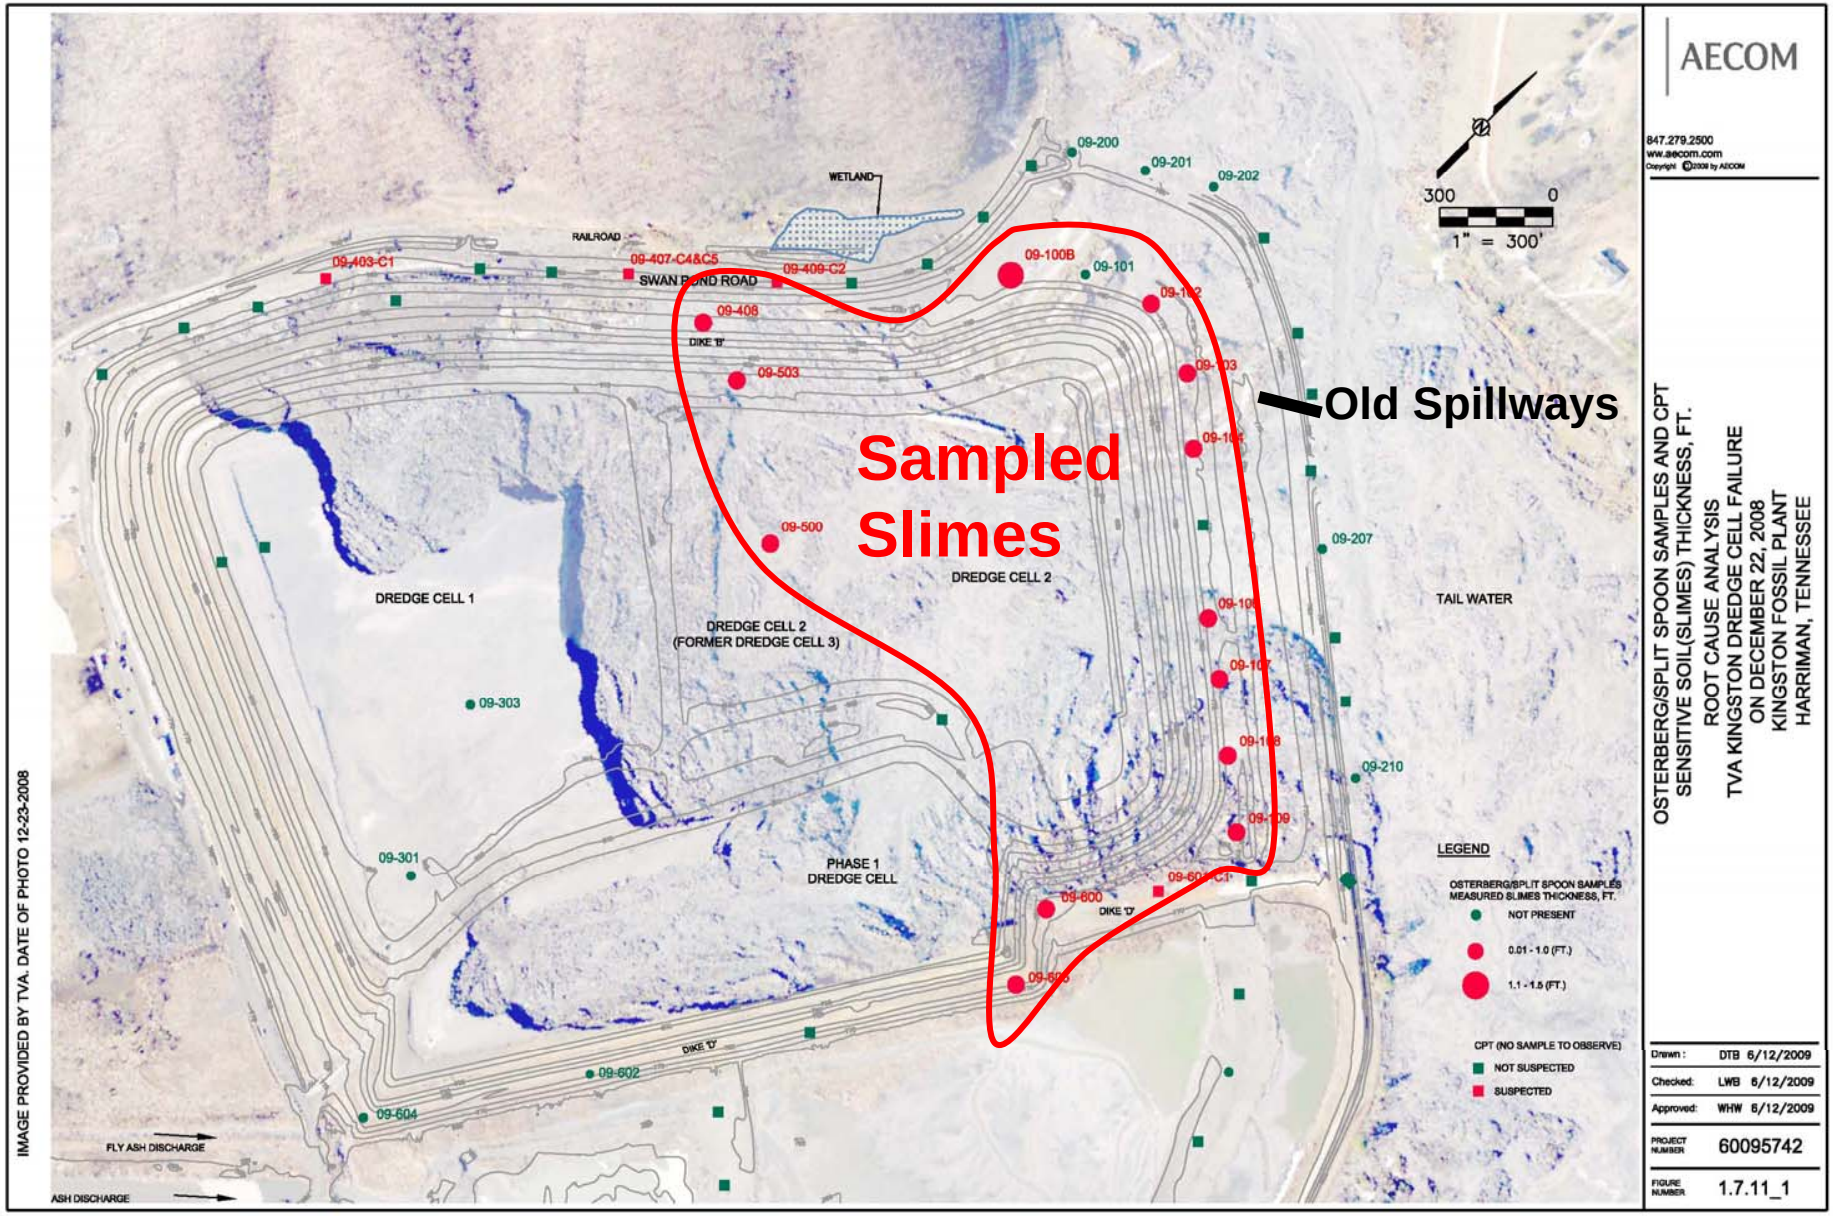
Location of Silt and Flyash Slimes Under Cell 2

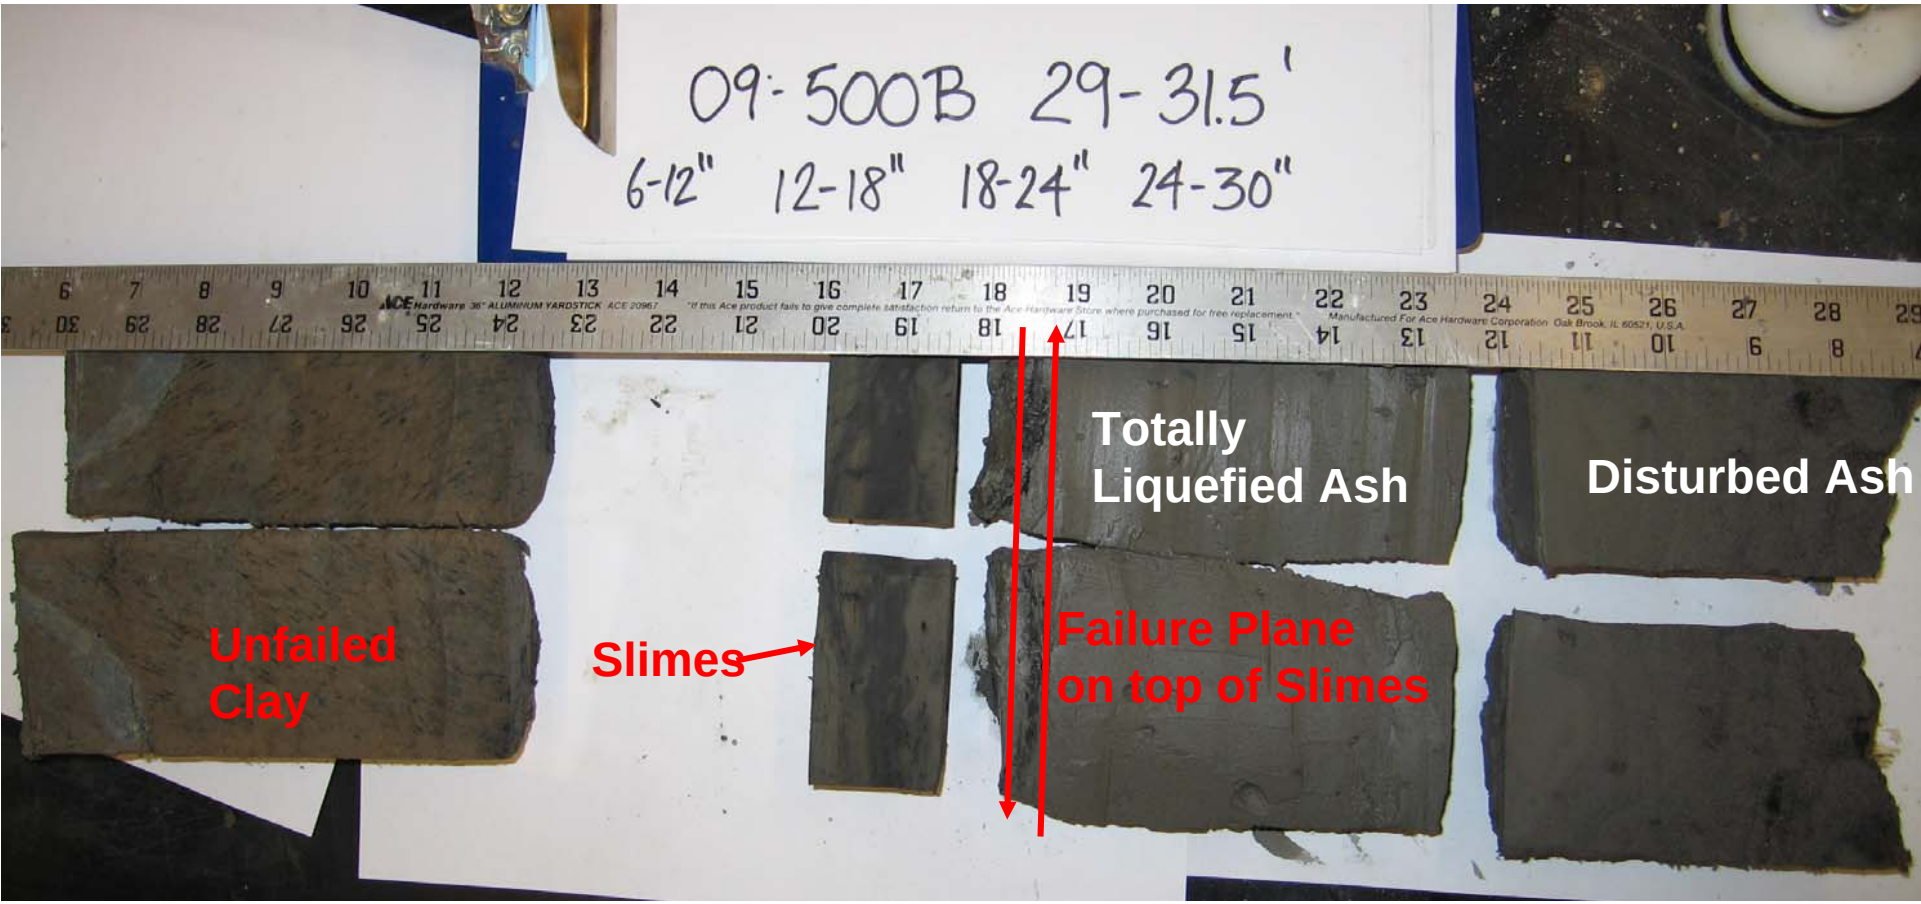
Clay/Laminated Slimes/Failed Ash at 09-500B, OST5

09-500B S5 29.0 to 31.5 ft

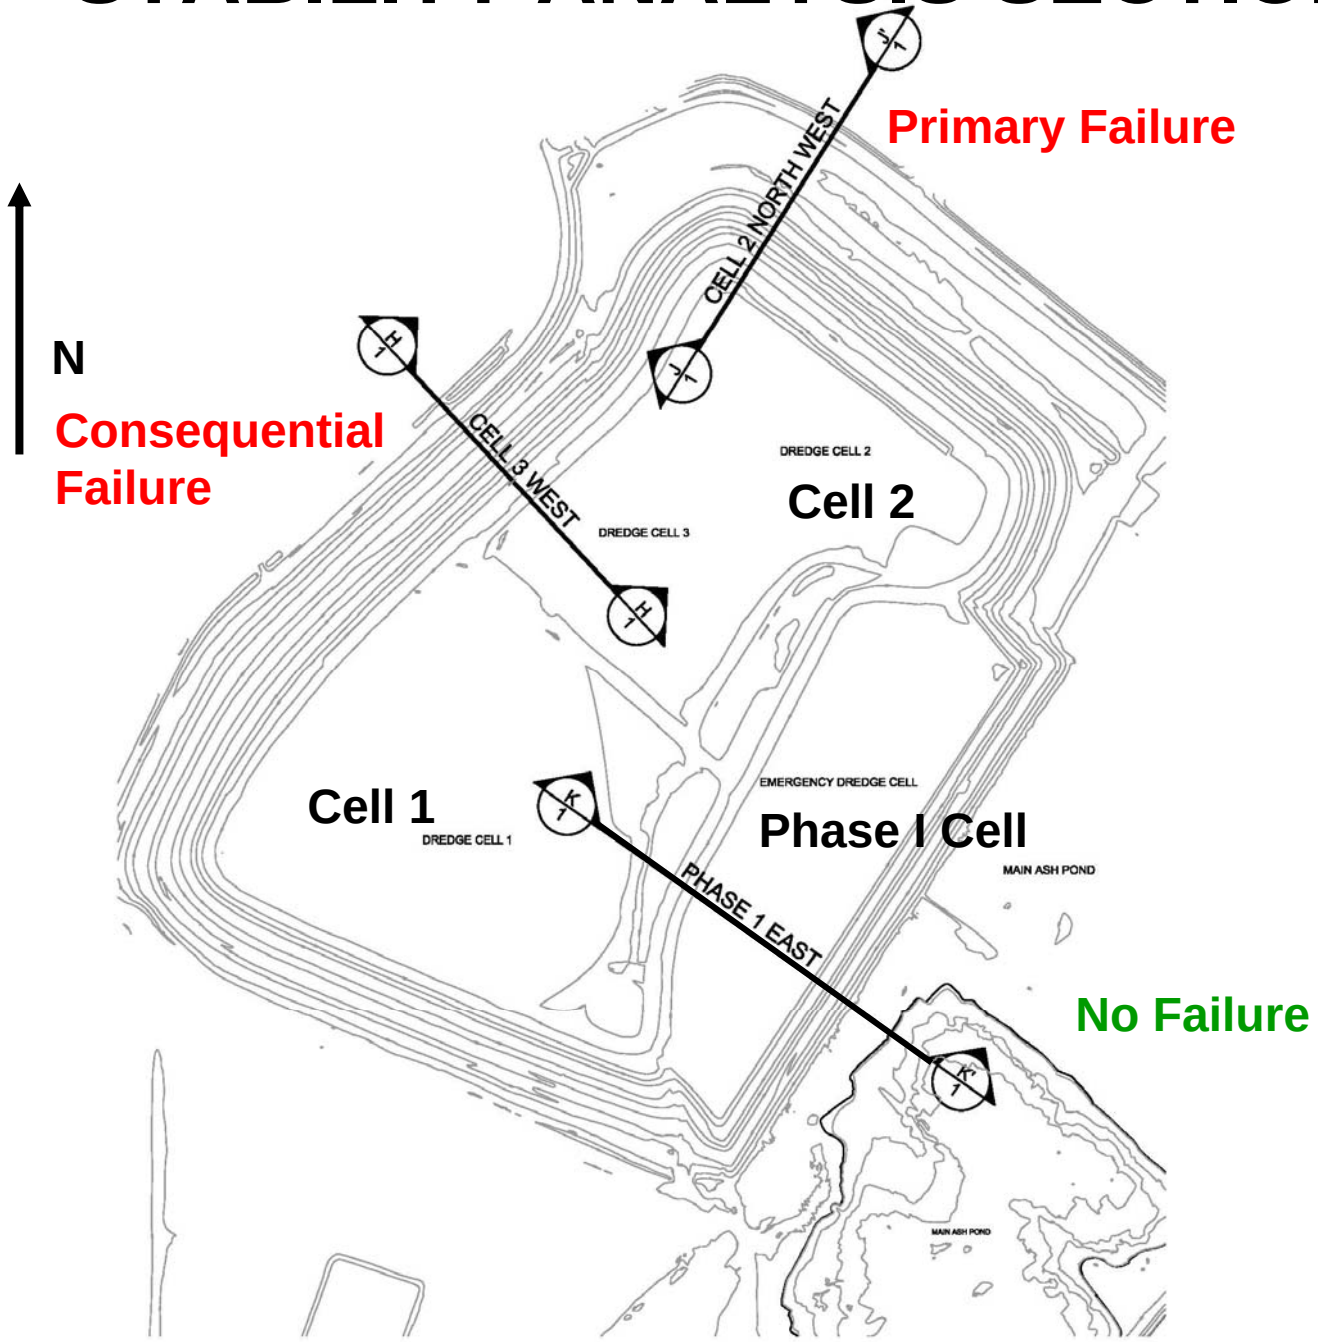
STABILITY ANALYSIS SECTIONS

Stage 1 - Initiation of Failure at North Side of Dredge Cell 2

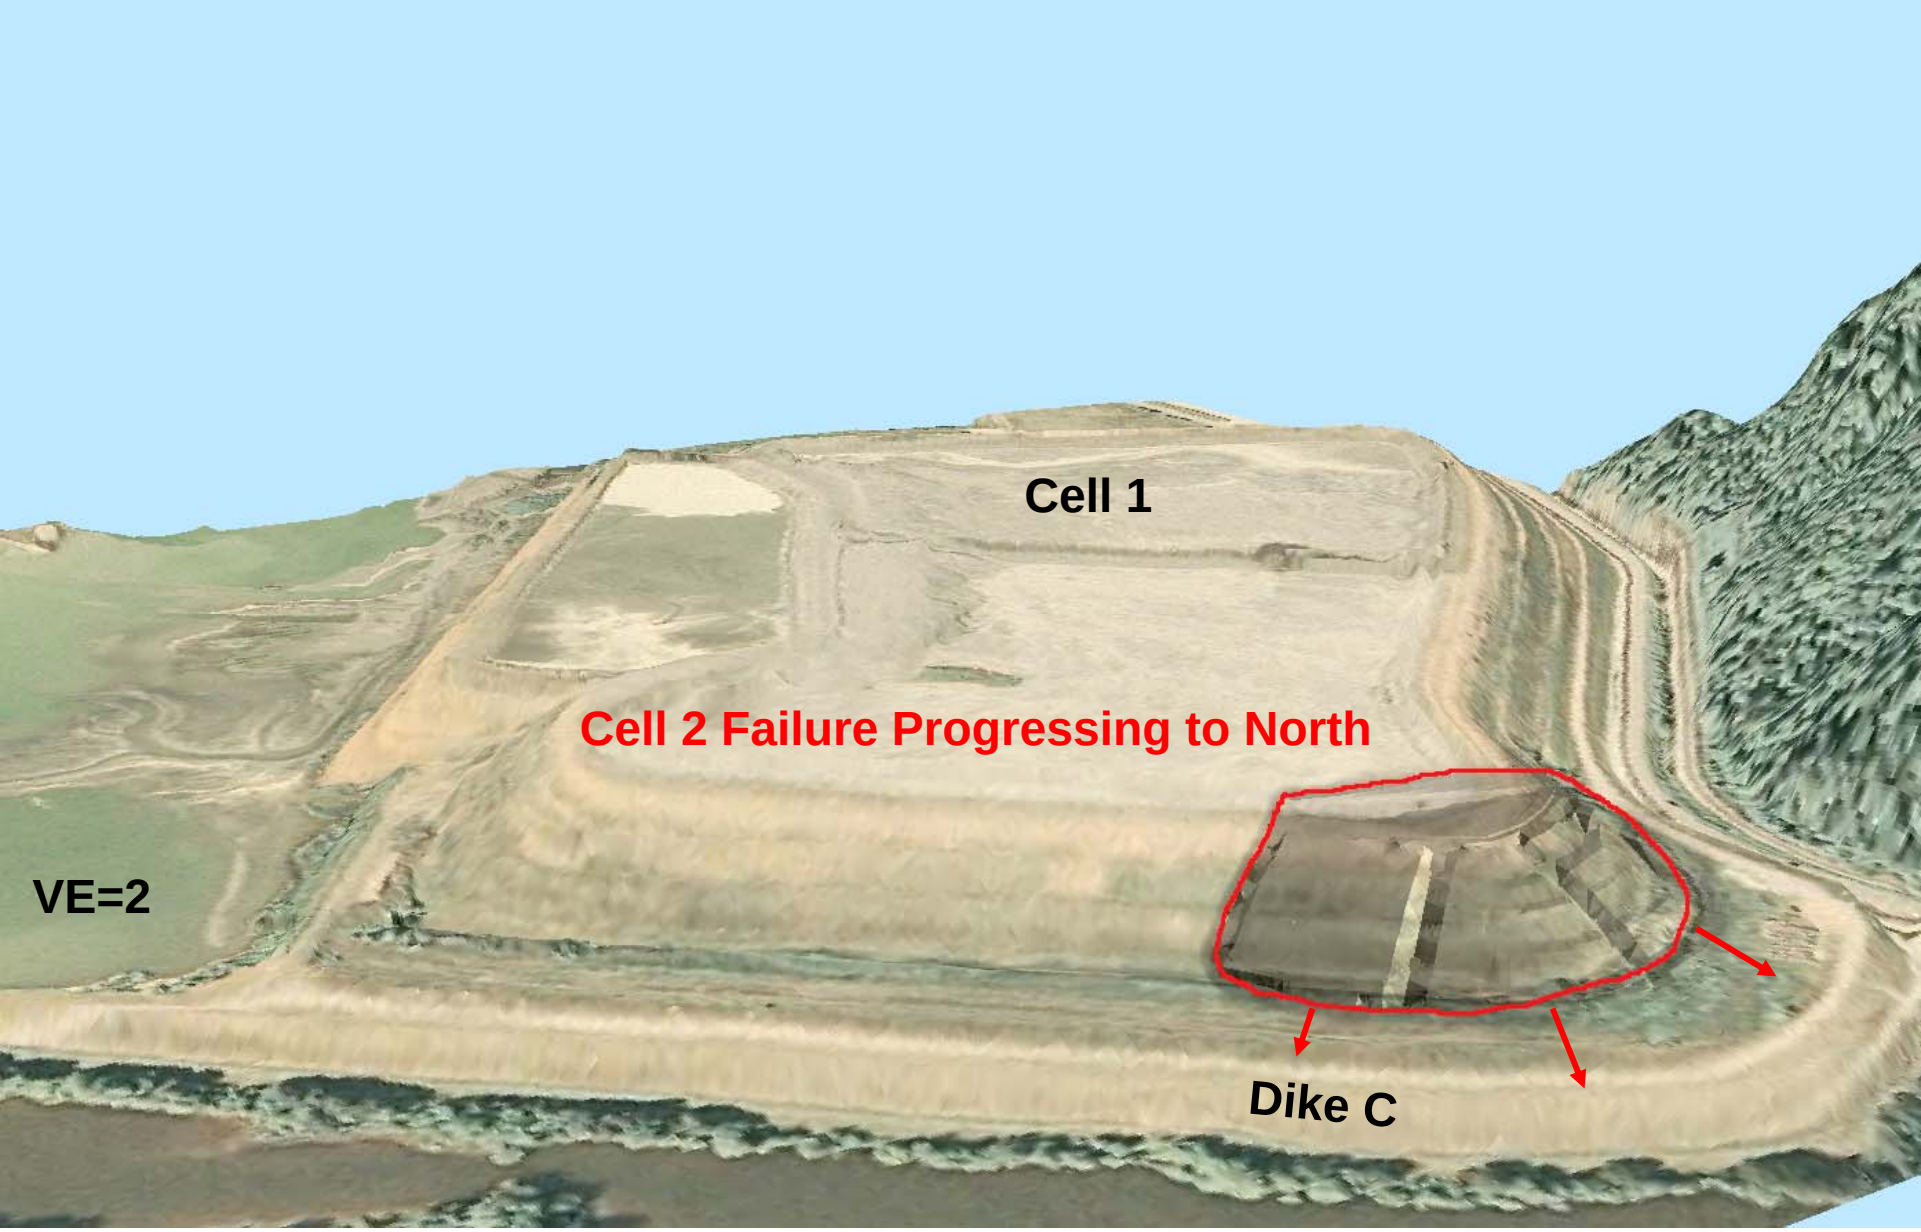
December 22, 2008 Expected Failure Mode at NW Corner of Cell 2

Stage 2 – Ash & Dikes A thru D2 Pile Up Against Dike C. This Surcharge and increased Ash Pressure Causes Dike C to Fail

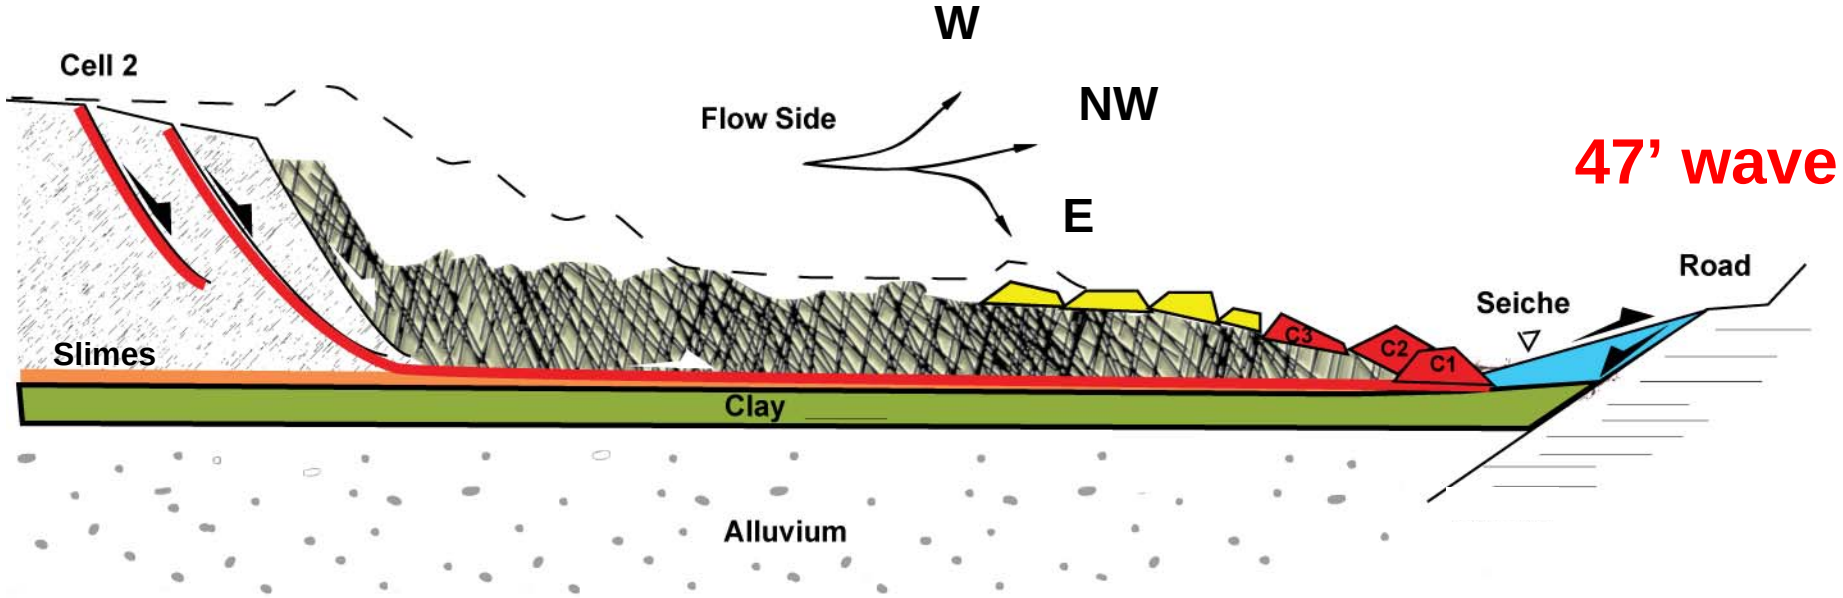
Stage 3 – Progressive Failure Southward that Fails North and West Dikes A thru D2 Back to Cell 1 Di Dike. 5.4 Million CY Fill Sloughs and Reservoir

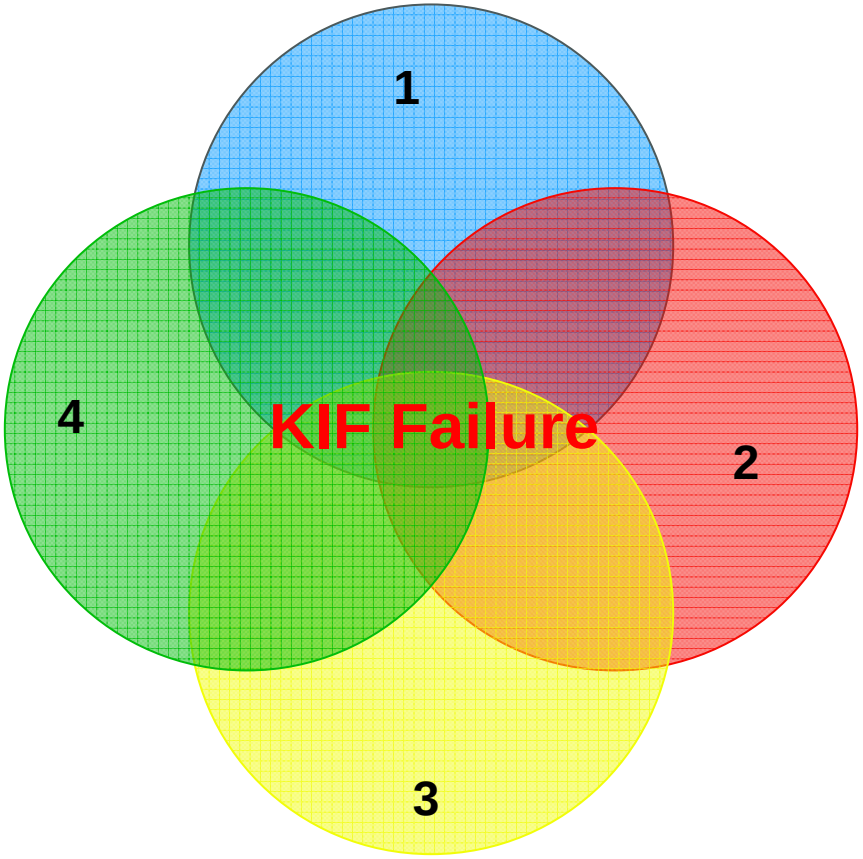
Increased Loads Due to Higher Fill

Hydraulically Placed Loose Wet Ash

Fill Geometry & Setbacks

<u>Unusually</u> Weak Slimes Foundation
